Number: SB 500-21-003, Rev B
Model: ECLIPSE EA500
Subject: Integrated Twin Pack Compressor Pallet Assembly
(ITPCA) Inspection/Repair

To improve the thermal operating margin of the primary power interface connection between the controller and each of the compressors

This Service Bulletin provides the aircraft effectivity and replacement of the controller to compressor power electrical interface slide connector located in the controller assembly of the ITPCA.

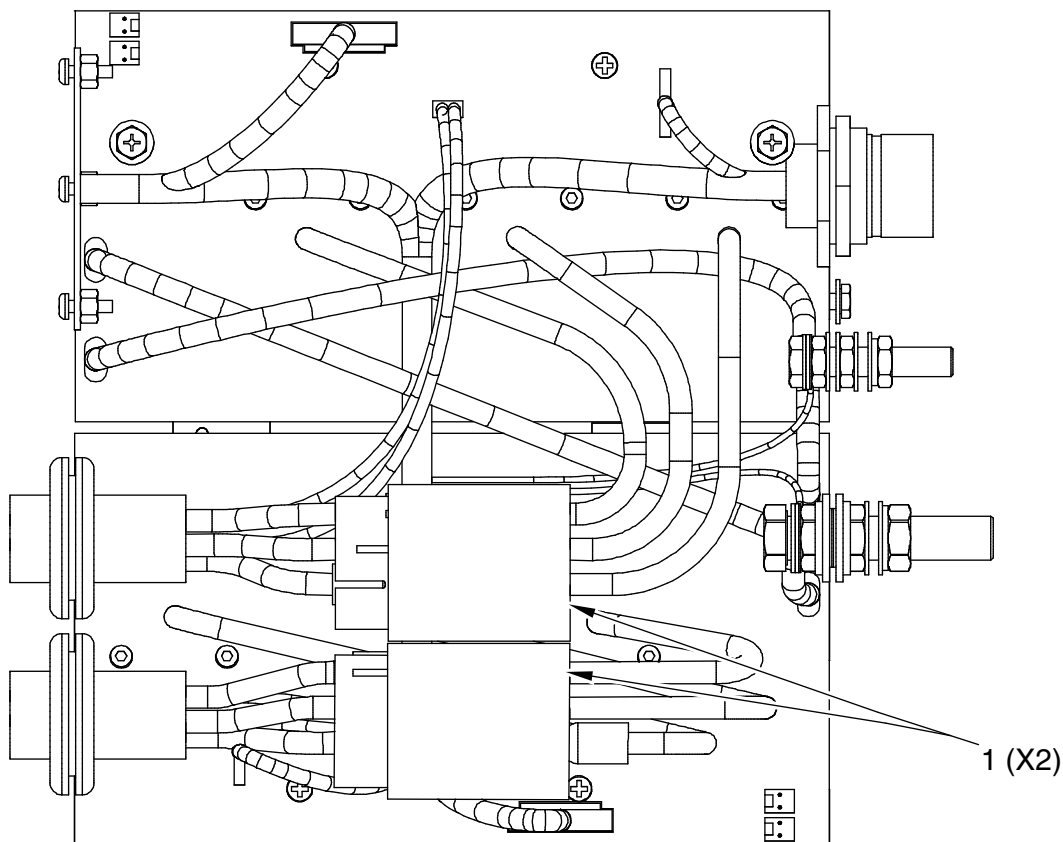
Figure 4

- (10) Each power cable assembly to each compressor is made up of 5 conductors. The three large conductors are the power conductors which terminate at the large black slide connectors (1, Figure 4). The two smaller conductors are signal conductors. Do not cut or change the two small conductors.

NOTE: If evidence of wire, connector or terminal overheating is discovered. Remove and replace ITPCA. Refer to AMM - 21-10-11 - INTEGRATED TWIN PACK COMPRESSOR ASSEMBLY - REMOVAL and AMM - 21-10-11 - INTEGRATED TWIN PACK COMPRESSOR ASSEMBLY - INSTALLATION.

With a pair of appropriate wire cutters, cut each of the three large conductors on each side of the large interface connector (1, Figure 4) as close to the connector as possible. A total of 12 wires shall be cut, 6 associated with each compressor. Remove and discard the black slide connectors (1, Figure 4).
