NUMBER: SB 500-24-008, Rev B
MODEL: ECLIPSE EA500
SUBJECT: External Power Receptacle Inspection

Mandatory

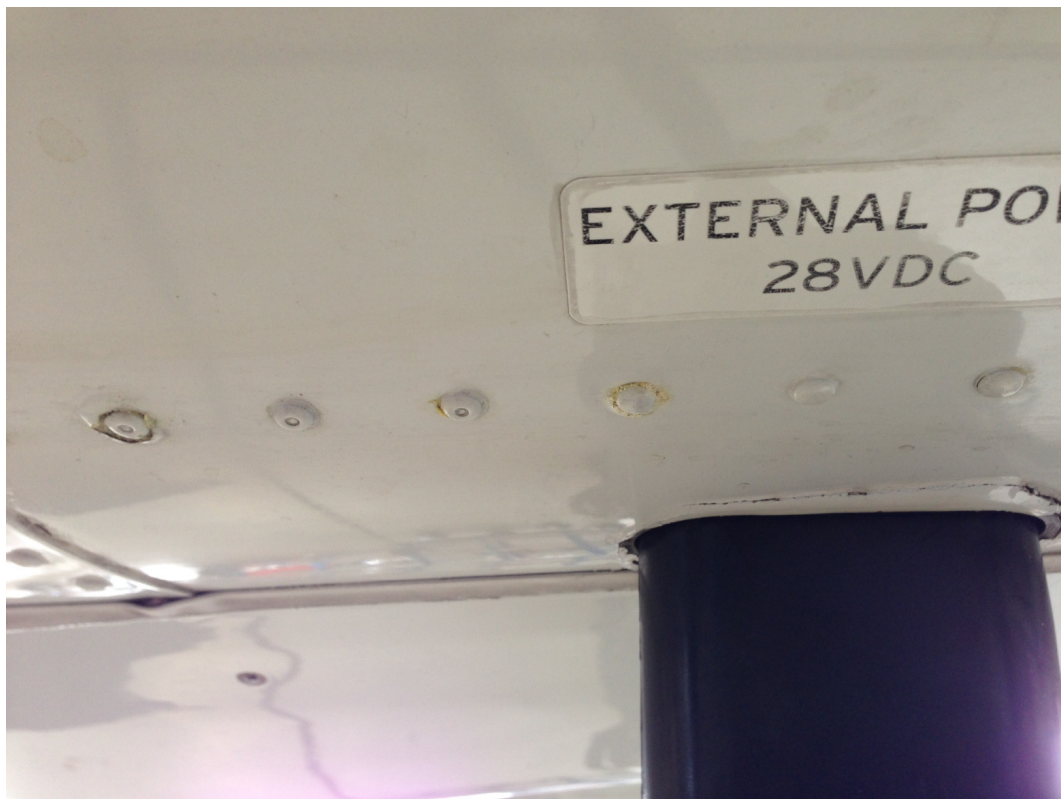
Figure 2. External Power Receptacle Rivet Corrosion

- discoloration of fasteners or structure
 - material erosion along edges
 - Corrosion as evidenced by white powder (Aluminum Oxide) buildup
- (5) If evidence of damage is found, contact Eclipse Service Engineering for additional instructions.
- (6) Remove all tools, equipment and unwanted material from the work area.
- (7) Reinstall the following:
 - (a) The 251 FL - Left Aft Wing-to-Body Fairing, per AMM-53-11-13.
 - (b) The 252 EL - Right Aft Wing-to-Body Fairing, per AMM-53-11-13.
 - (c) The 321 DB - Vertical Access Panel, per AMM-55-30-13.
- (8) If all other maintenance is complete, return the aircraft to service. Refer to the AMM 20-00-02 RETURN TO SERVICE (AFTER MAINTENANCE).

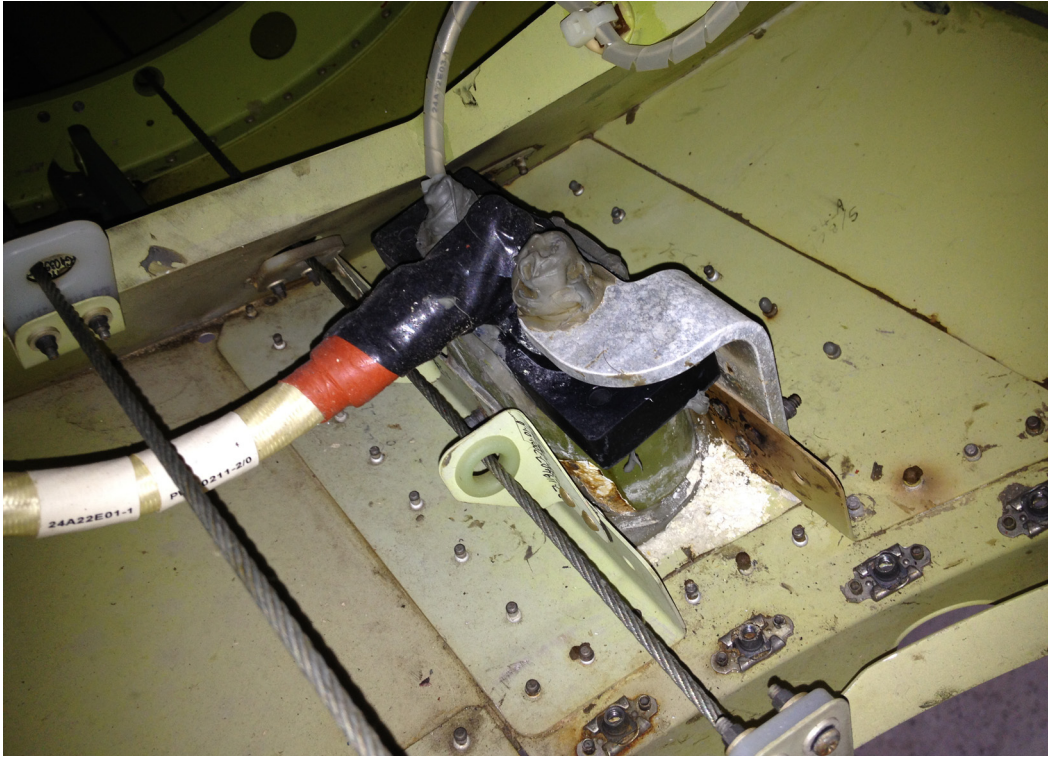
Typical internal damage may be:

Figure 5. Internal Electrical Damage

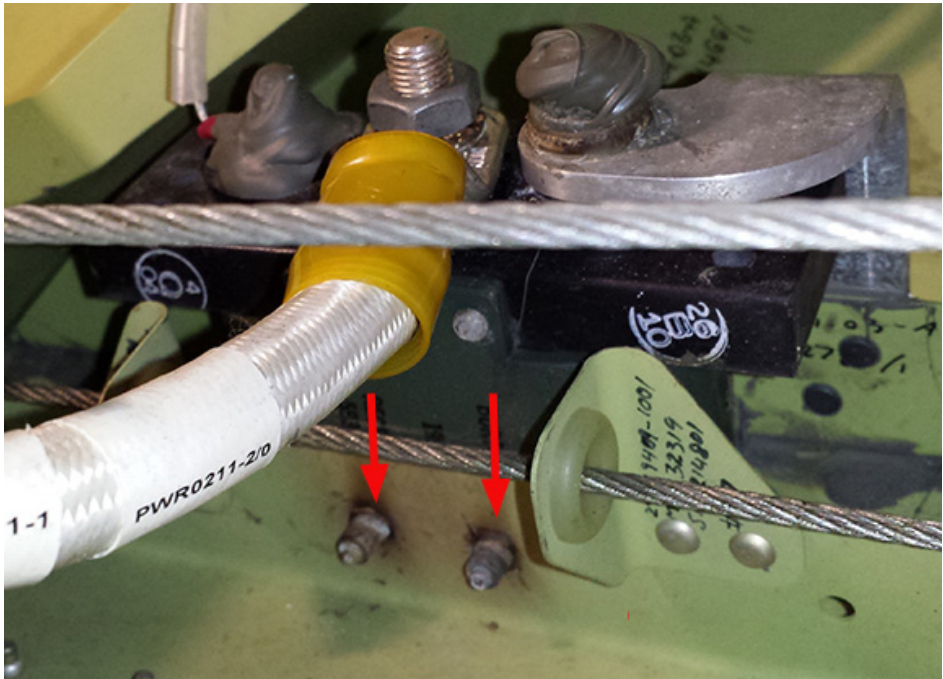
Figure 6. Internal Electrical Damage
