ECLIPSE
AEROSPACE

SERVICE BULLETIN

NUMBER: SB 500-26-002, REV A
MODEL: ECLIPSE EA500
SUBJECT: ENGINE FIRE DETECTION LOOP CAP SEAL INSPECTION

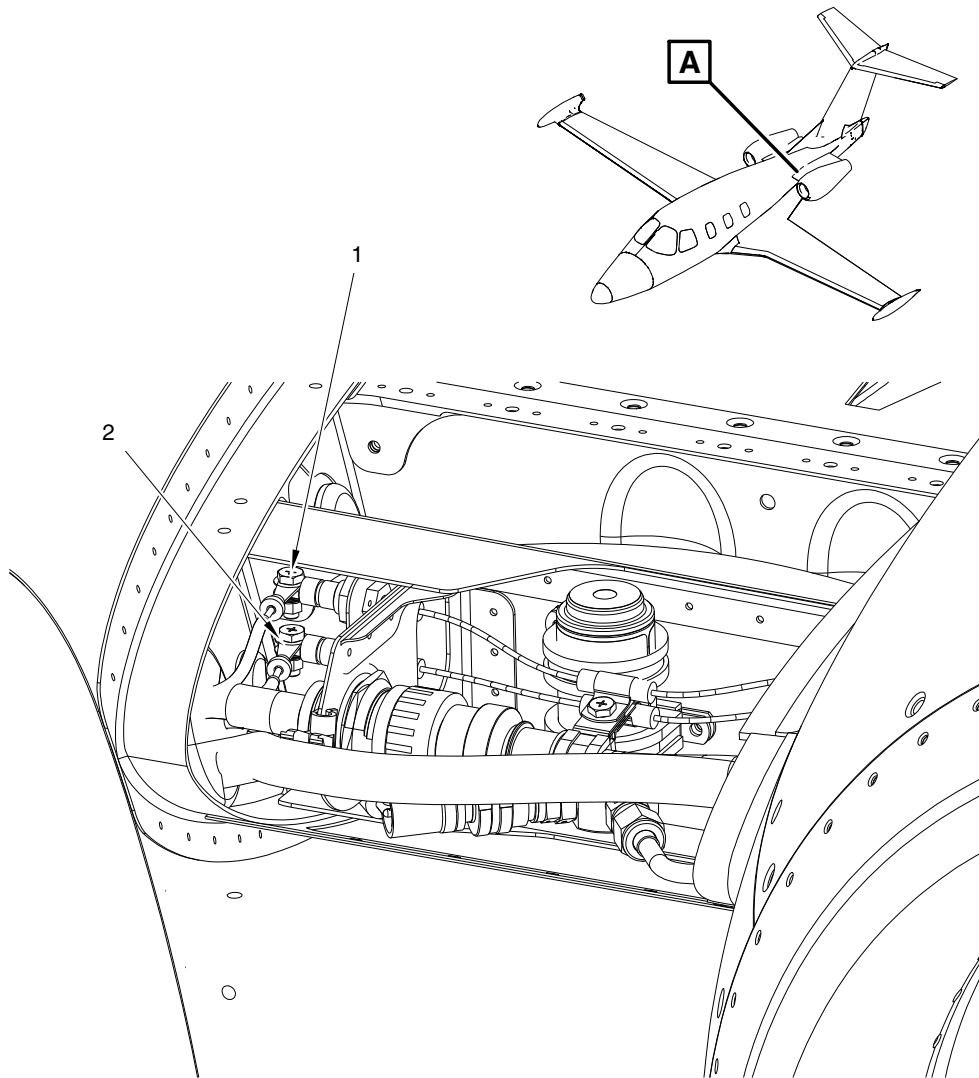
Fire Loop Terminals
Figure 1

Airplanes may have been delivered without complete cap sealing of the fire detection loop terminals which may result in premature removal or service of the fire loop.

- (3) Remove engine nacelle covers and skins as follows:
 - (a) Remove 411 AT - Left Upper Nacelle Cowl and 412 AT - Right Upper Nacelle Cowl. Refer to AMM - 54-20-21 - UPPER NACELLE - REMOVAL to gain access for .
 - (b) Remove left and right forward leading edge pylon skins. Refer to AMM - 54-30-11 - LEADING EDGE PYLON SKIN - REMOVAL.
- (4) Inspect left and right fire detection loop terminals ends (two per side) (1 and 2, Figure 1) for cap seal. If cap seal is present go to step 8. If cap seal is not present go to step 5.

- (5) Inspect left and right fire detection loop terminal ends (two per side) (1 and 2, Figure 1) for corrosion. If corrosion is present do the following:
- (a) Disassemble terminal connections (two per side) (1 and 2, Figure 1) by removing bolt (1, Figure 2), washer (2, Figure 2), terminal (aircraft harness side) (3, Figure 2), washer (5, Figure 2) and nut (4, Figure 2) that attach terminal (aircraft harness side) (3, Figure 2) to fire loop detection terminal (6, Figure 2). Refer to AMM - 26-12-10 - FIRE DETECTION WIRE - REMOVAL.
