NUMBER: SB 500-27-004, Rev C
MODEL: ECLIPSE EA500
SUBJECT: Aileron Joint Assembly Inspection and Replacement

Alert

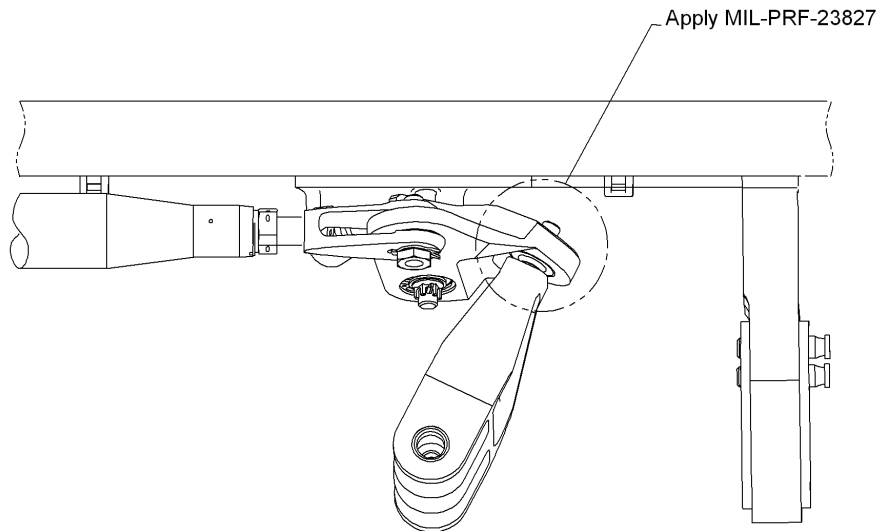
**Aileron Joint
Figure 1**

Possible corrosion of the Aileron joint assembly bearing or shaft resulting in aileron friction being out of tolerance. Corrective action is to inspect aileron joint and replace with redesigned parts.

- (1) Make sure bearing and pin is clean and dry, apply ROYCO 27 (MIL-PRF-23827 or equivalent) around the pin and bearing area ([Figure 1](#)) after initial inspection. Reapply every 100 hours subsequent. Refer to AMM 20-10-00-051-911-005 CORROSION PREVENTION.
