NUMBER: SB 500-30-002, Rev C
MODEL: ECLIPSE EA500
SUBJECT: Inspection and Treatment of Wing and Tail De-Ice
Boots Installation for Surface Corrosion

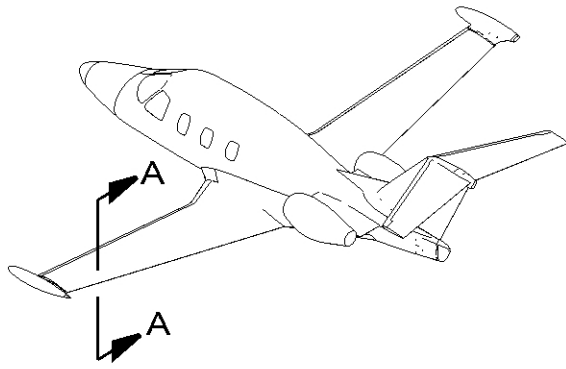
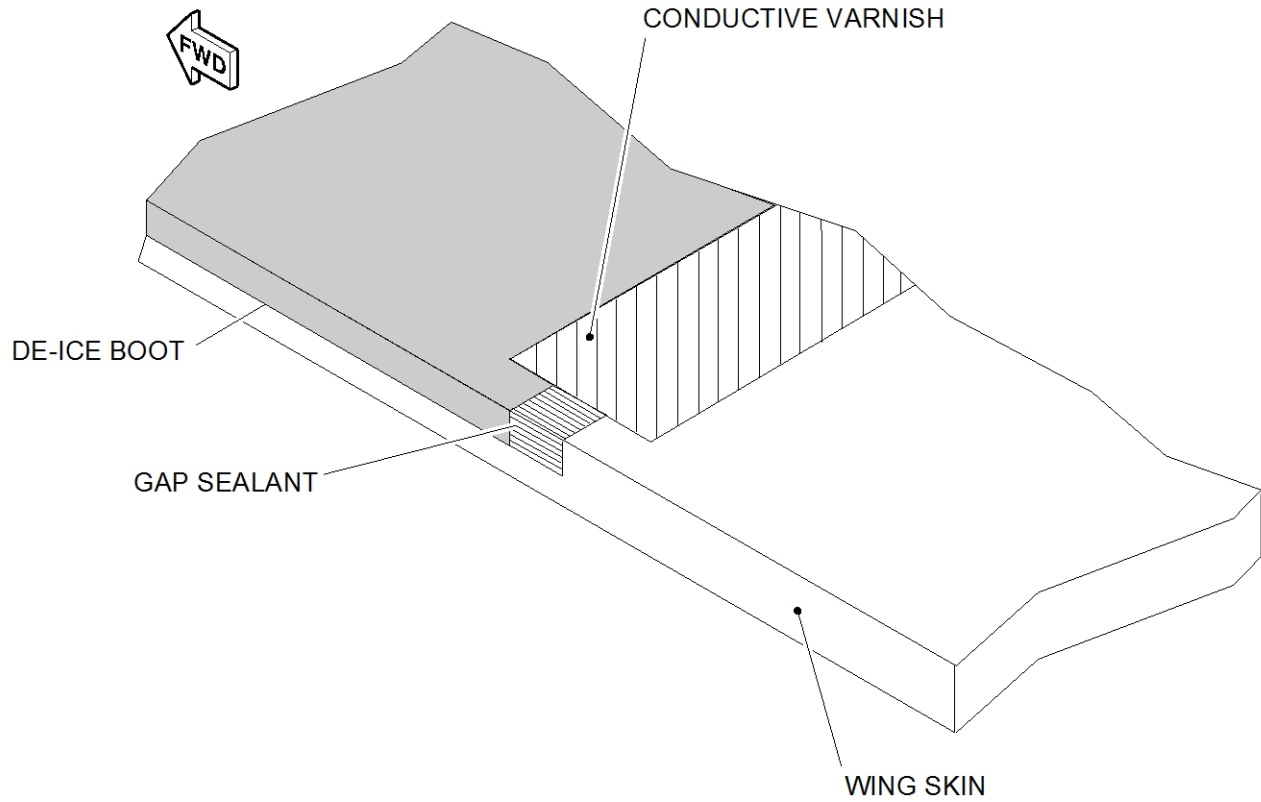
**Left Wing De-ice Boot
Figure 1**

- (b) Starting from the wing tip, do a Detailed Visual Inspection (DVI) of the exposed area of the wing skin between the de-ice boot and top coat finish for evidence of corrosion (refer to Figure 1). Inspect the upper and lower surfaces of the wing from the wing tip to the wing root.

- (c) Indication of corrosion may include (but is not limited to) any of the following. Refer to AMM - 20-10-00 - CORROSION:
 1. Blister under the varnish.

2. Dull gray appearance of the wing skin if varnish is missing.
 3. White powder on the wing skin if varnish is missing.
 4. Visible pits in the wing skin.

- (a) Apply a protective covering on the wing/horizontal stabilizer topcoat finish in the areas aft of the varnish application.
(b) Apply chemical conversion coating to the exposed wing/horizontal stabilizer skins as per AMM - 20-09-00 - AIRCRAFT FINISHES.
NOTE: Do not apply primer to areas to be covered by conductive varnish.
(c) If primer was removed from the leading edge skin apply epoxy primer to the affected area. Refer to AMM - 20-09-00 - AIRCRAFT FINISHES.
(d) If boot gap sealant was removed re-apply sealant PR2050-B1/2 to the affected area. Refer to AMM - 30-10-10 - WING DEICE BOOT - INSTALLATION and AMM - 20-08-00 - SEALANTS AND ADHESIVES - MAINTENANCE PRACTICES.

- (a) Apply conductive varnish to the wing and horizontal stabilizer surfaces, refer to AMM - 30-10-10 - WING DEICE BOOT - INSTALLATION, AMM - 30-10-11 - HORIZONTAL STABILIZER DEICE BOOT - INSTALLATION and AMM - 20-08-00 - SEALANTS AND ADHESIVES - MAINTENANCE PRACTICES.
(b) Apply clearcoat as a protective topcoat over conductive varnish, per AMM - 20-09-00 - AIRCRAFT FINISHES.
