SERVICE BULLETIN

NUMBER: SB 500-31-008, REV B
MODEL: ECLIPSE EA500
SUBJECT: DIAGNOSTIC STORAGE UNIT (DSU) ELECTRICAL CONNECTOR UPGRADE

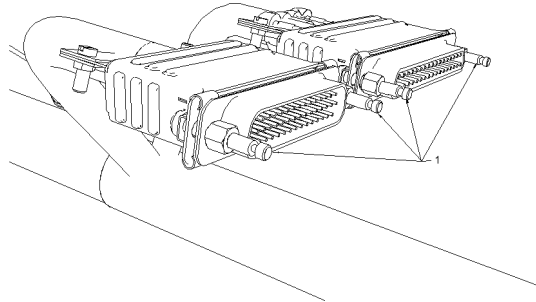
Figure 3

The slide lock retention device on the DSU electrical connectors does not always provide connector retention.

- (9) Remove the DSU (6, Figure 1) from the rails (2, Figure 1) and (7, Figure 1).
- (10) Remove and discard the attachment hardware (1, Figure 3) from the harness connectors at 39A10P01 and 39A10P02.
