SERVICE BULLETIN

NUMBER: SB 500-31-009, REV B
MODEL: ECLIPSE EA500
SUBJECT: DIAGNOSTIC STORAGE UNIT (DSU) SPARES

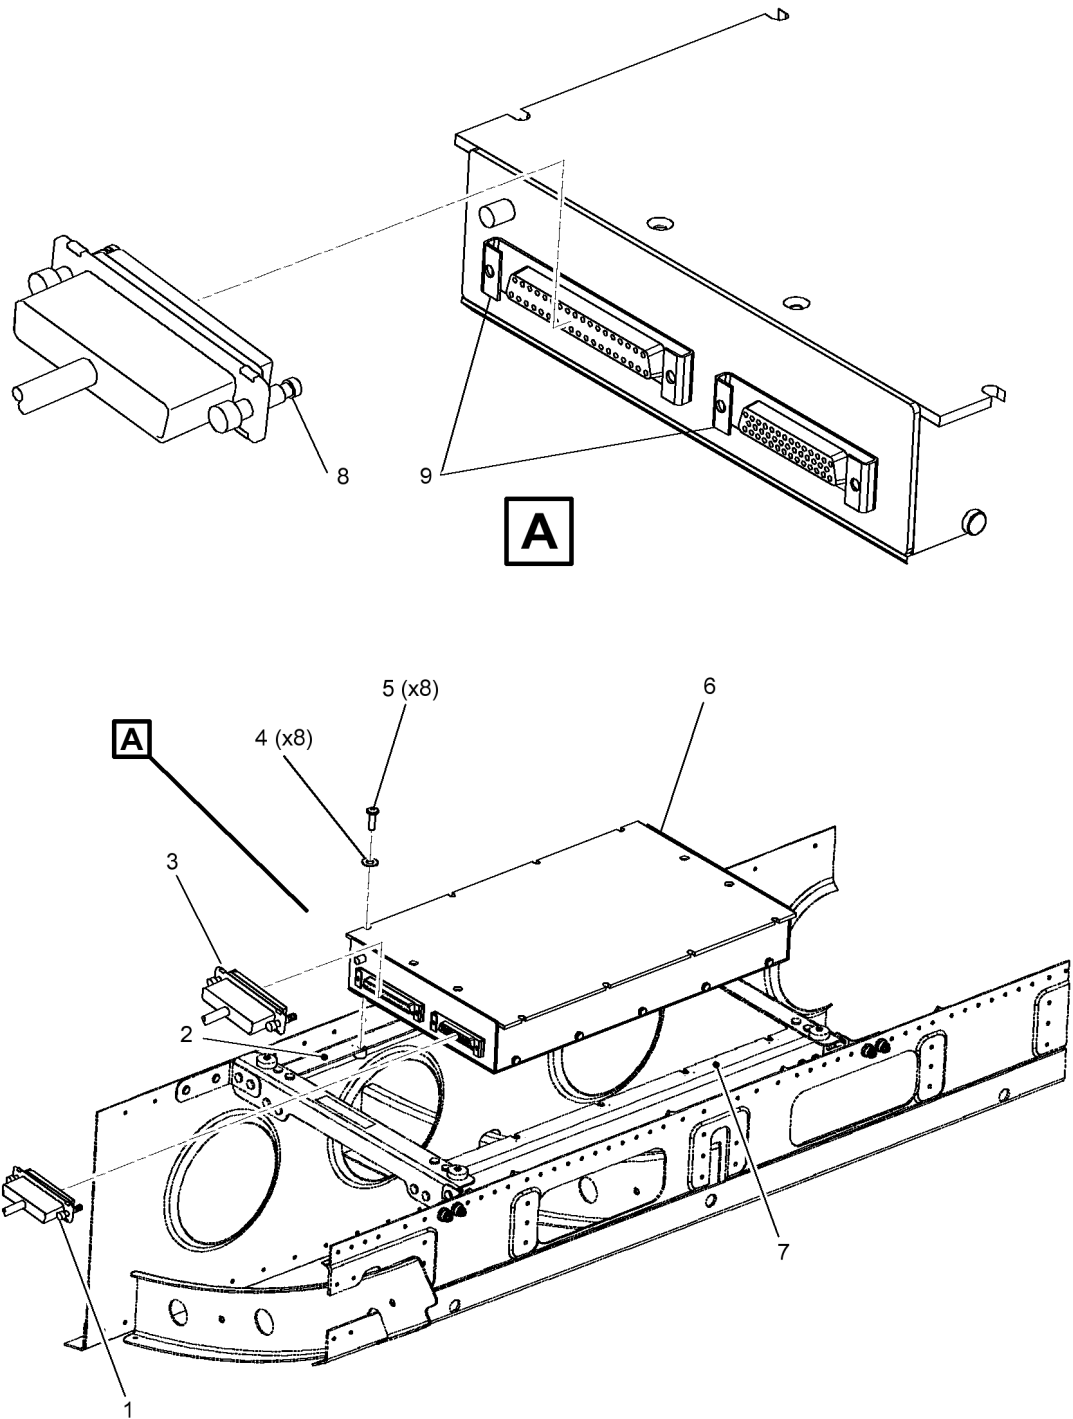
DSU Removal / Installation
Figure 1 (Sheet 1 of 1)

NOTE: DSU P/N 11-0323-07-A and the harness connector (8, Figure 1) and (1, Figure 2) can be identified by the slide style retention device (9, Figure 1) on the DSU.

- (8) Disconnect the electrical connectors 39A10P01 and 39A10P02 (1, Figure 1) and (3, Figure 1) from the DSU (6, Figure 1).
- (9) Disconnect coax connector 39A10P03 from the DSU.

- (10) Remove the eight bolts (5, Figure 1) and washers (4, Figure 1) that attach the DSU (6, Figure 1) to the rails (2, Figure 1) and (7, Figure 1).
- (11) Remove the DSU P/N 11-0323-07-A (6, Figure 1) from the rails (2, Figure 1) and (7, Figure 1).
