SERVICE BULLETIN

NUMBER: SB 500-32-006, REV B
MODEL: ECLIPSE EA500
SUBJECT: LANDING GEAR EMERGENCY EXTENSION INSPECTION AND RIGGING

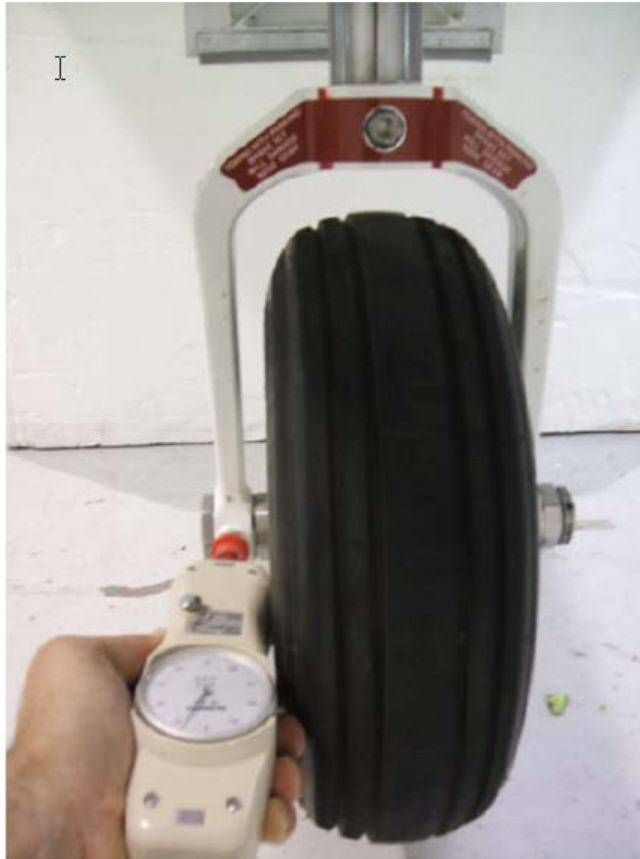
**Push-Pull Gauge Application to NLG
Figure 1 (Sheet 1 of 1)**

Location	Task/Responsibility
Cockpit	<ul style="list-style-type: none"> • Pull up emergency extension release handle. • Measure and record force required to bring emergency extension handle with push-pull force gauge to the UP position. Make sure force does not exceed 18 lbs (8.1 kg).
Nose Landing Gear (NLG)	<ul style="list-style-type: none"> • Push NLG to the down and locked position with push-pull force gauge (refer to Figure 1). Be sure to push NLG while gear is in transit. • Measure and record force required to extend NLG to down and locked position. Make sure force does not exceed 25 lbs (11.3 kg).
Main Landing Gear (MLG)	<ul style="list-style-type: none"> • Make sure both MLG extend to the down and locked position. Make sure transit time does not exceed 2.5 seconds. • Make sure MLG extension is smooth.

MLG does not extend and lock in 2.5 seconds or less	Do an adjustment/test of main landing gear and doors. Refer to AMM 32-10-00.
Force required to pull NLG to the down and locked position 25 lbs (11.3 kg)	Do an adjustment/test of the NLG and doors. Refer to AMM 32-20-00.
