SERVICE BULLETIN

NUMBER:	SB 500-33-001, REV A
MODEL:	ECLIPSE EA500
SUBJECT:	LANDING LIGHT BALLAST LOCATION INSPECTION/REWORK

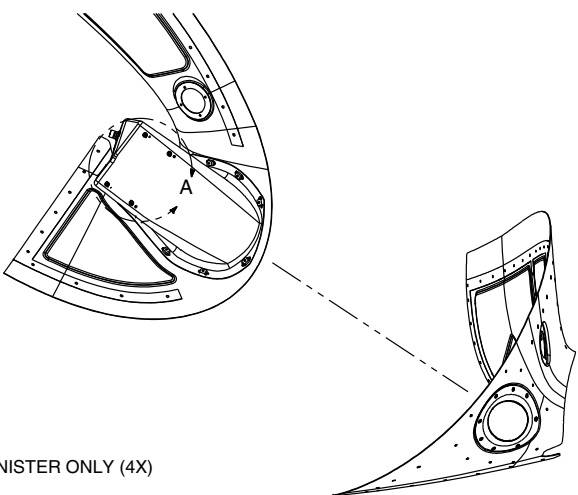
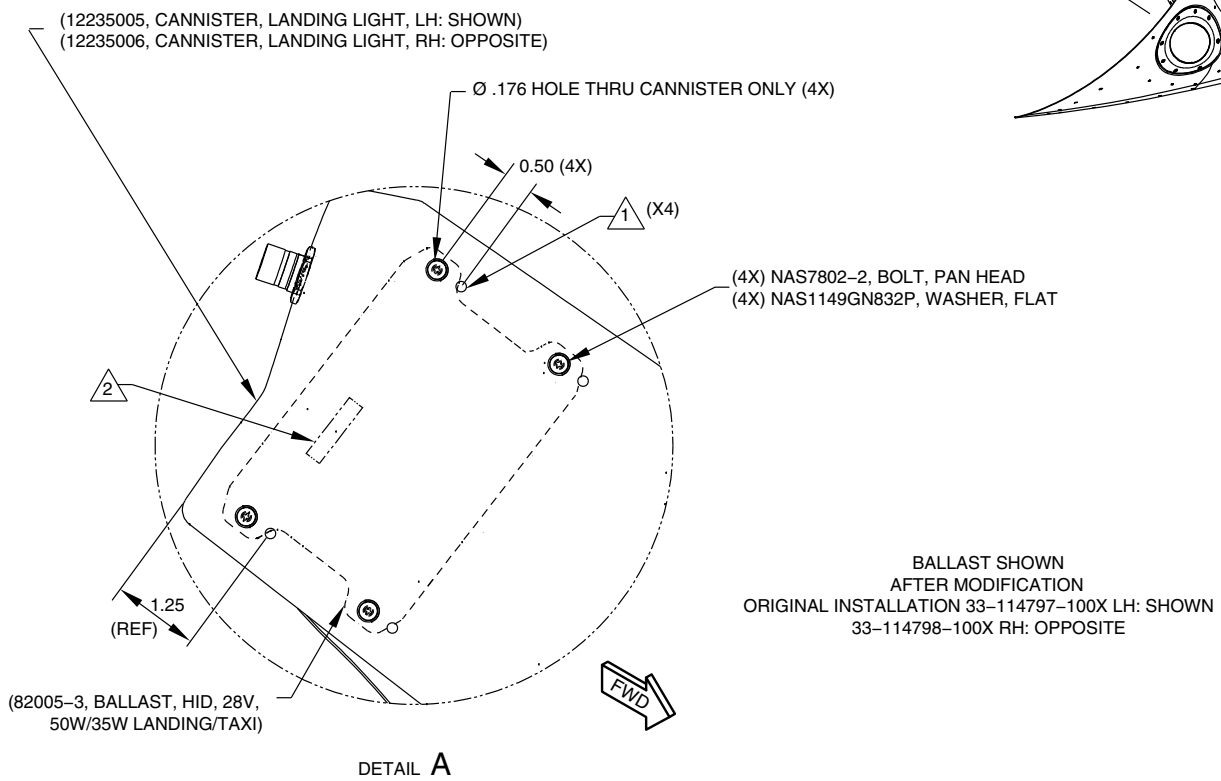
Landing Light Ballast Rework
Figure 1

- (3) Inspect left and right Landing Light Canister for 1.25 inch (REF) distance from aft ballast mounting hole to the exterior back of canister. Refer to [\(REF\) Detail A, Figure 1](#).
NOTE: The Landing Light Ballast does not need to be removed to measure the REF dimension. Measure from the center of the fastener to the outside edge of the cannister.

- (4) Remove affected left and/or right Landing Light Ballast. Refer to AMM 33-40-19 BALLAST, LANDING LIGHT - REMOVAL.
- (5) Locate and drill four 0.176 diameter holes into landing light cannister. Refer to [Figure 1](#).

- (6) Fill original holes (X4) ([Flag Note 1](#), [Figure 1](#)) with PPG Aerospace (PRC-DeSoto) PR-2001, Type 2, Class B sealant. Build up sealant a minimum of 0.05 inch above the surface of the cannister on both sides. Sealant must extend beyond the edge of hole onto the cannister surface a minimum of 0.03 inch.
NOTE: Allow sealant to cure before installing the ballast.

- (7) Mark cannister with indelible ink at location ([Flag Note 2](#), [Figure 1](#)) "Part Modified per SB 500-33-001".
- (8) Re-clock electrical connector backshells ([1 and 2](#), [Figure 2](#)) as shown for both left and right sides.
