SERVICE BULLETIN

NUMBER: SB 500-52-008, REV B
MODEL: ECLIPSE EA500
SUBJECT: MAIN LANDING GEAR-LOWER DOOR AERO SEAL MODIFICATION

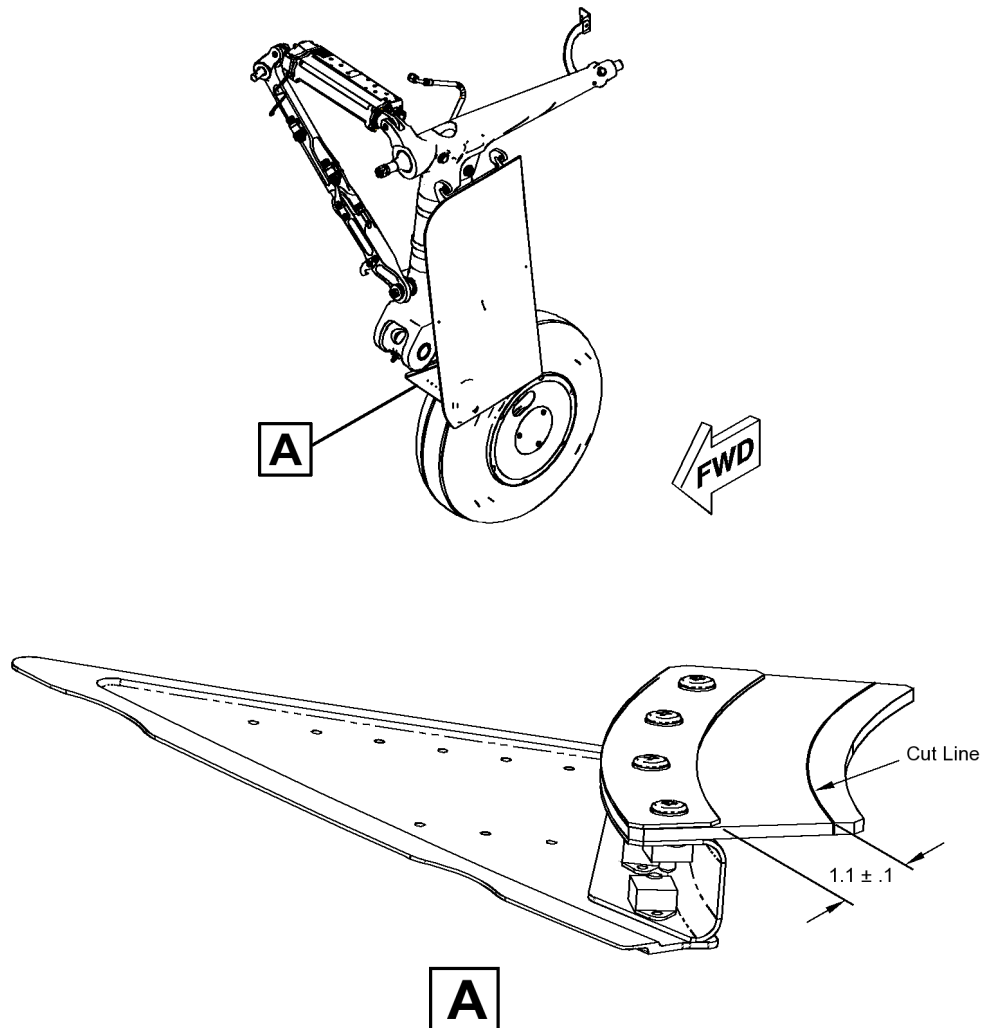
Main Landing Gear-Lower Door Aero Seal Figure 1

Performance of this modification will prevent the possibility of interference between the main landing gear lower aero door seal and main gear tire.

- (1) Make aircraft safe for maintenance. Refer to AMM 20-00-01.
- (2) Remove left Main Landing Gear-Lower Door. Refer to AMM 52-82-11 Main Landing Gear-Lower Door Assembly Removal
- (3) Mark and rework aero seal (P/N 52-109214-2002) to obtain $1.1 \pm .1$ inch from retaining bracket (P/N 52-114011-2001). Refer to [Figure. 1](#).
