SERVICE BULLETIN

NUMBER: SB 500-54-002, REV B
MODEL: ECLIPSE EA500
SUBJECT: ENGINE TAIL CONE PRIMER

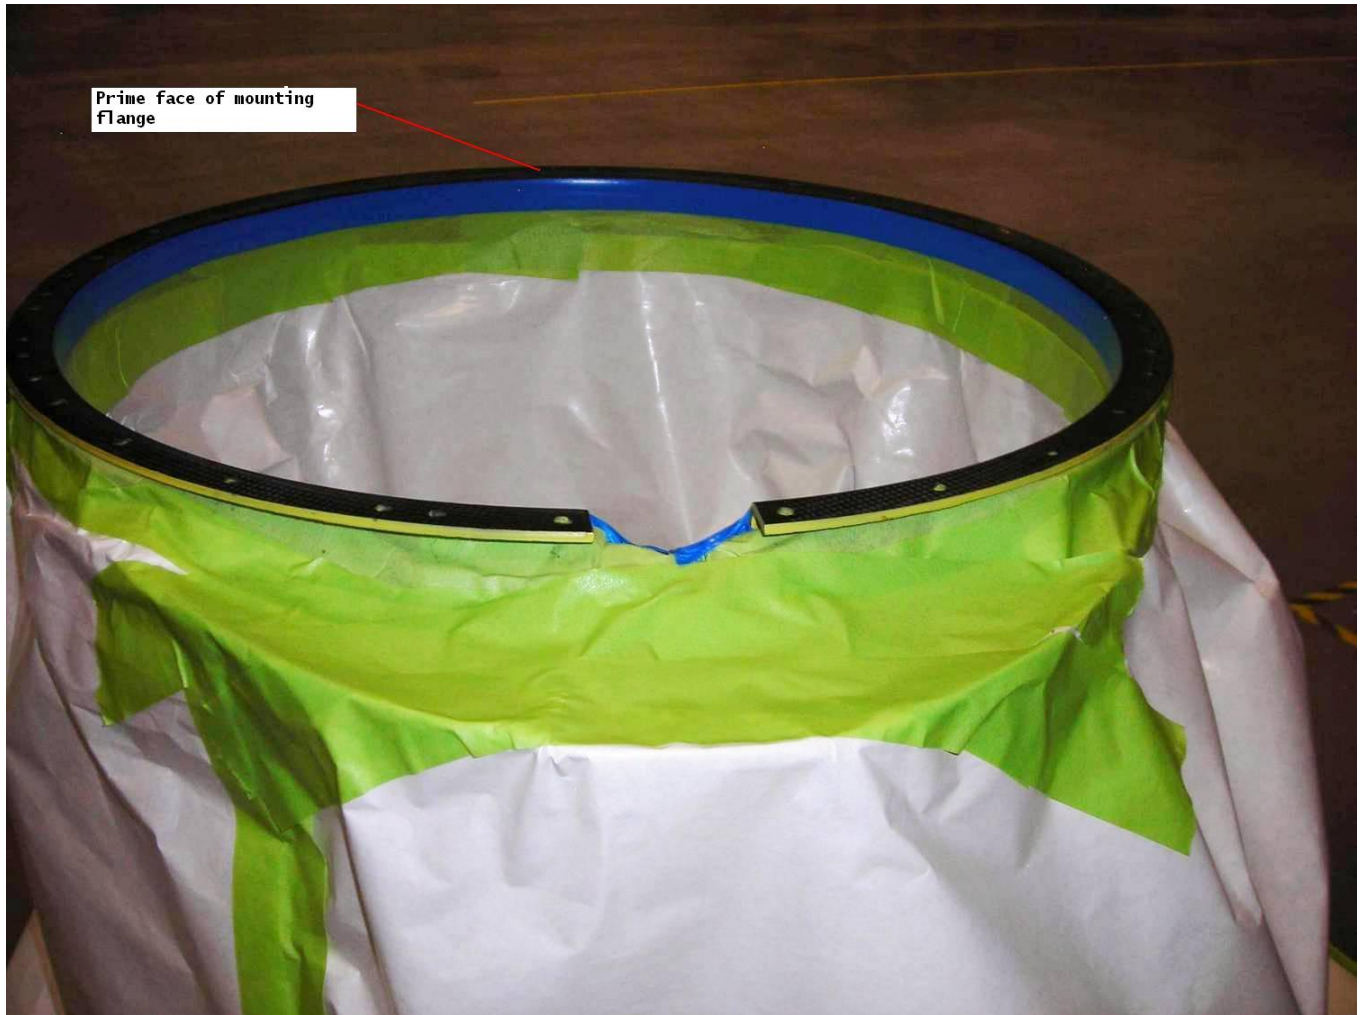
**Tail cone flange
Figure 1**

Engine exhaust tail cone requires primer on mounting flange.

- (2) Mask off tail cone to prevent overspray. Do not coat inside of tail cone. Refer to [Figure 1](#).
- (3) Clean a second time prior to coating by wiping with a clean cloth moistened with Methyl Ethyl Ketone (MEK) or Isopropyl Alcohol, changing cloths as necessary when they become discolored or otherwise contaminated. Wipe dry immediately after the solvent moistened cloth with a clean, dry cloth before the solvent has a chance to completely evaporate. Refer to AMM 20-09-00 SURFACE PREPARATION.

- (4) Apply two coats of MIL-PRF-23377 epoxy primer. Apply primer to the following dry film thickness of 0.0010 – 0.0018 in. (25-46 microns). Refer to AMM 20-09-00 APPLICATION (epoxy primer).
