NUMBER: SB 500-54-005, Rev A
MODEL: ECLIPSE EA500
SUBJECT: Right Pylon Inspection and Repair

The right pylon frame attachment to the fuselage rivets may become damaged.

This Service Bulletin provides instructions to inspect and repair structure where the right pylon frame attaches to the fuselage.

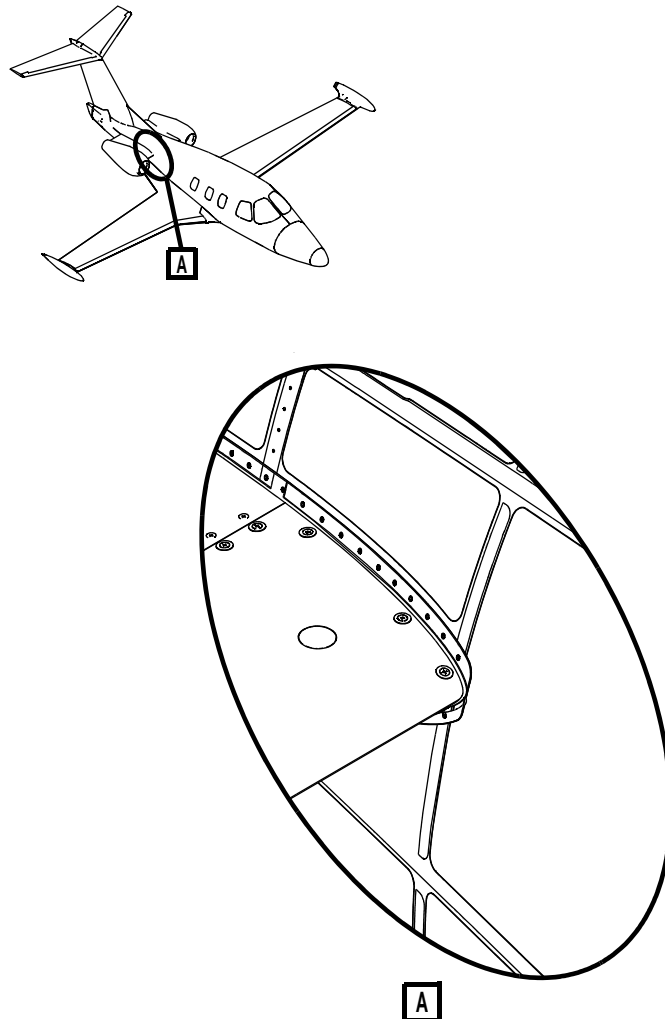
- (1) Inspect the area where the Frame, Pylon, Aft Fuselage, RH (p/n 53-114187) attaches to the aft fuselage for damaged rivets. Refer to [Figure 1](#), [Figure 2](#), and [Figure 3](#).
 - (a) If damage is noted, proceed to the Repair section.

Figure 1. Area of Inspection
