SERVICE BULLETIN

NUMBER: SB 500-55-001 Rev. B
MODEL: Eclipse EA500
SUBJECT: Horizontal Stabilizer Inspection

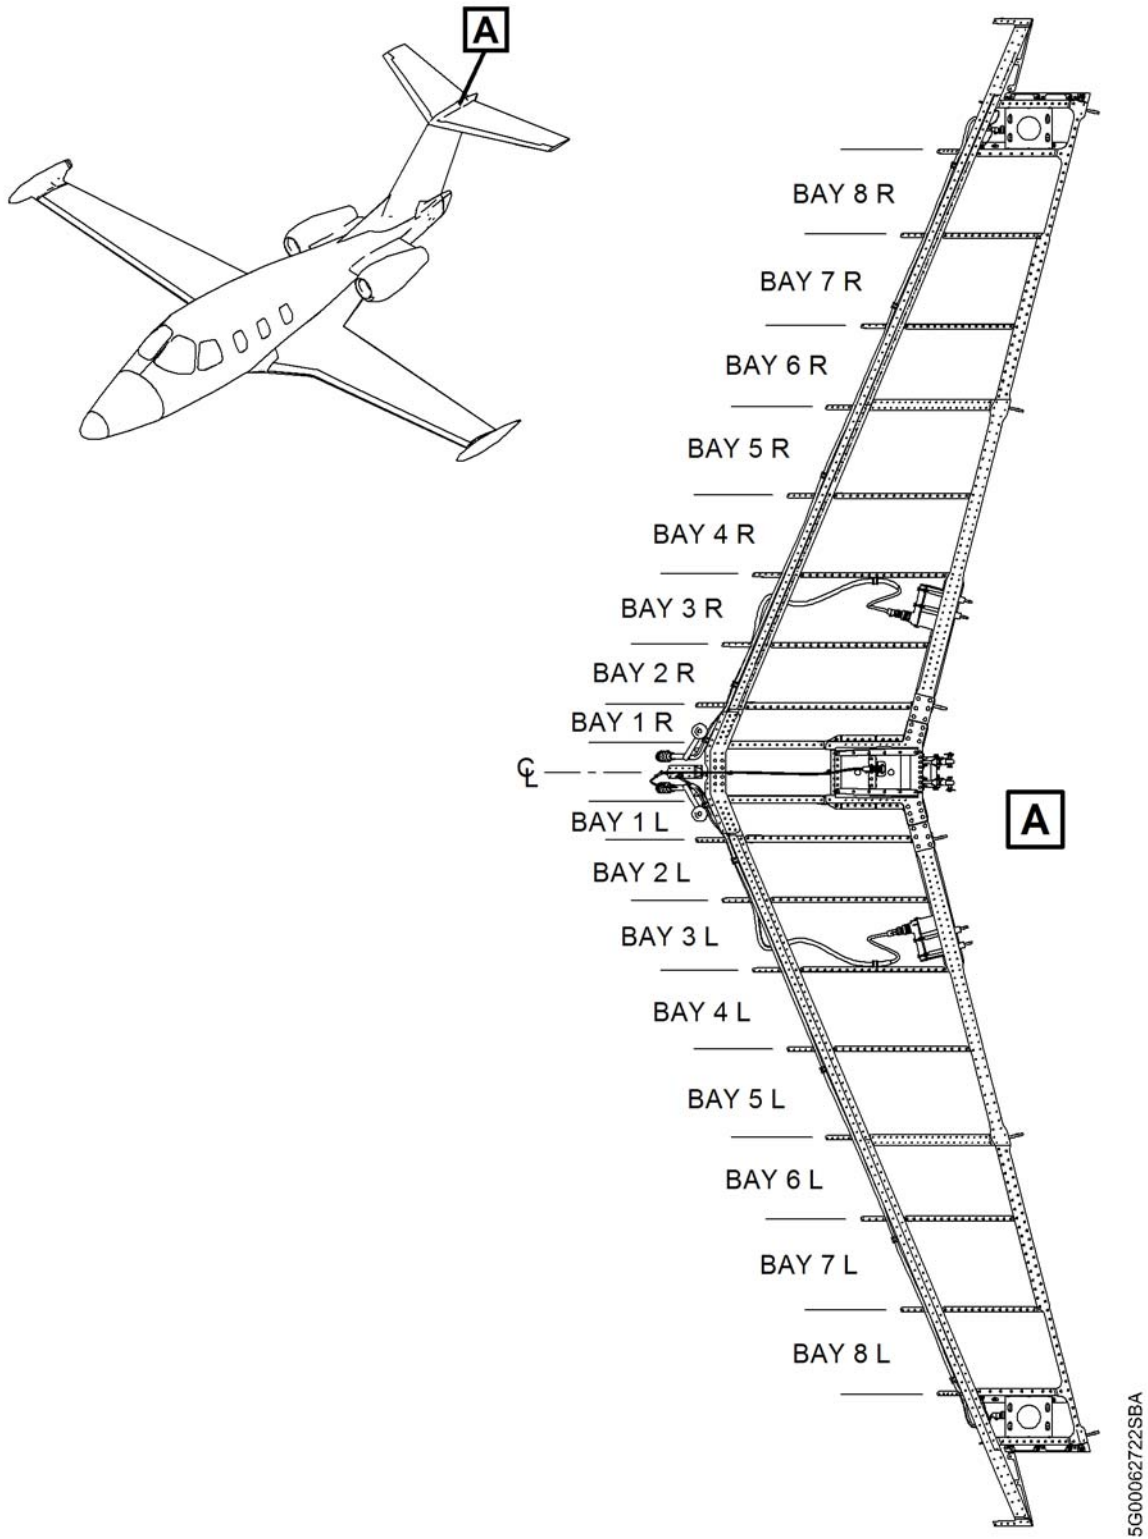
- (4) Inspect the whole "Bay" area. Bay #1 is composed of: Left side of Rib #1, right side of Rib #2, aft side of Forward Spar between Rib #1 and 2, forward side of the Aft Spar between Rib #1 and 2, upper and lower skins between Rib #1 and 2. Inspection should focus on finding drill bit markings where the drill bits used to drill fastener holes attaching the skin to the internal structure may have accidentally scored a rib, a spar, or a skin.

Note: For bore scope of the aft section of the Horizontal Stabilizer: make sure bore scope optic is at 90 degrees pointing toward aft rib attachment points to aft spar.
