SERVICE BULLETIN

NUMBER: SB 500-57-005
MODEL: ECLIPSE EA500
SUBJECT: WING TIP TANK FASTENER INSPECTION-REPAIR

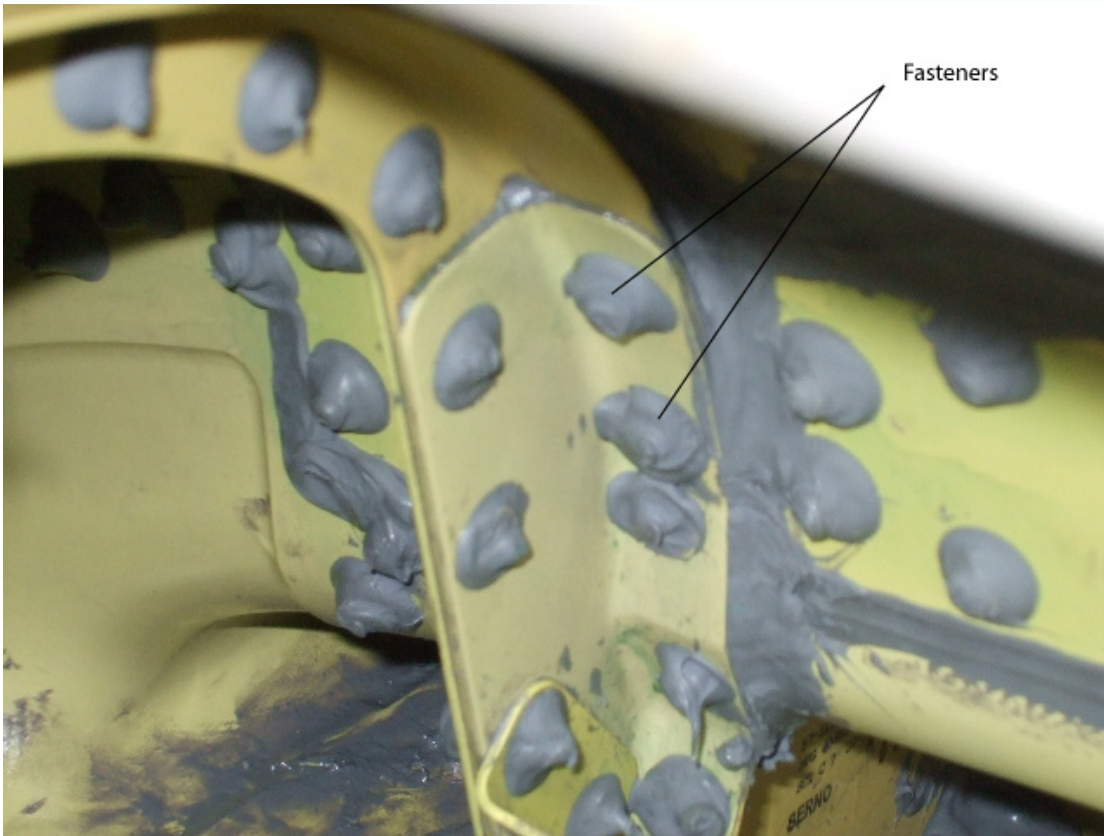
**Correct Installation of Fasteners - Left Side Tank View Looking Forward and Inboard
Figure 2 (Sheet 1 of 1)**

- (1) Inspect both the left and right tip tanks.
- (2) Defuel, if necessary, enough fuel to make sure that the tip tanks are empty.
- (3) Remove tip tank filler cap. Refer to AMM-28-10-10 Fuel Tank Filler Cap – Removal, Config B.
- (4) Navigating through the fuel tank filler port with a borescope, check that two fasteners are installed on the Forward Spar Former and Support as shown in Figure 2.

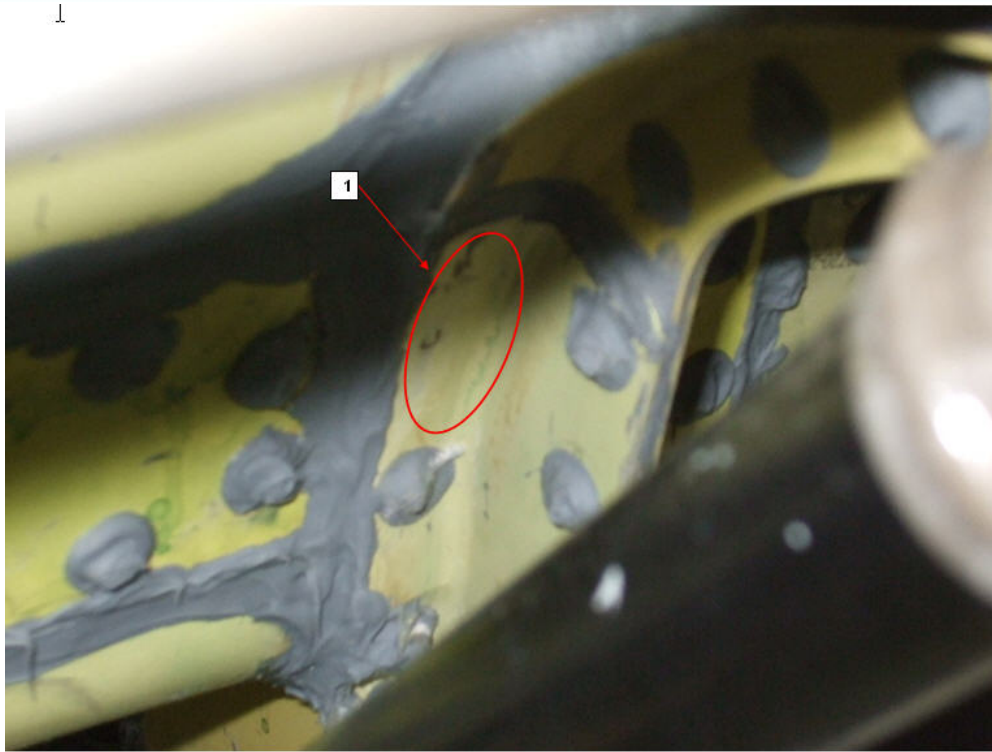
**Missing Fasteners - Right Side Tank, View Looking Forward and Inboard
Figure 3 (Sheet 1 of 1)**

Tip tank fasteners may be missing on certain extended tip tank aircraft. Extended tip tank aircraft S/N 000047 and up are not affected.

- (5) If fasteners are missing (1, Fig 3, Sheet 1), proceed to repair procedure. If not, continue to the next step.
