## SERVICE BULLETIN

**NUMBER:** SB 500-71-001, REV A  
**MODEL:** ECLIPSE EA500  
**SUBJECT:** STARTER GENERATOR POWER/GROUND GROMMET REWORK

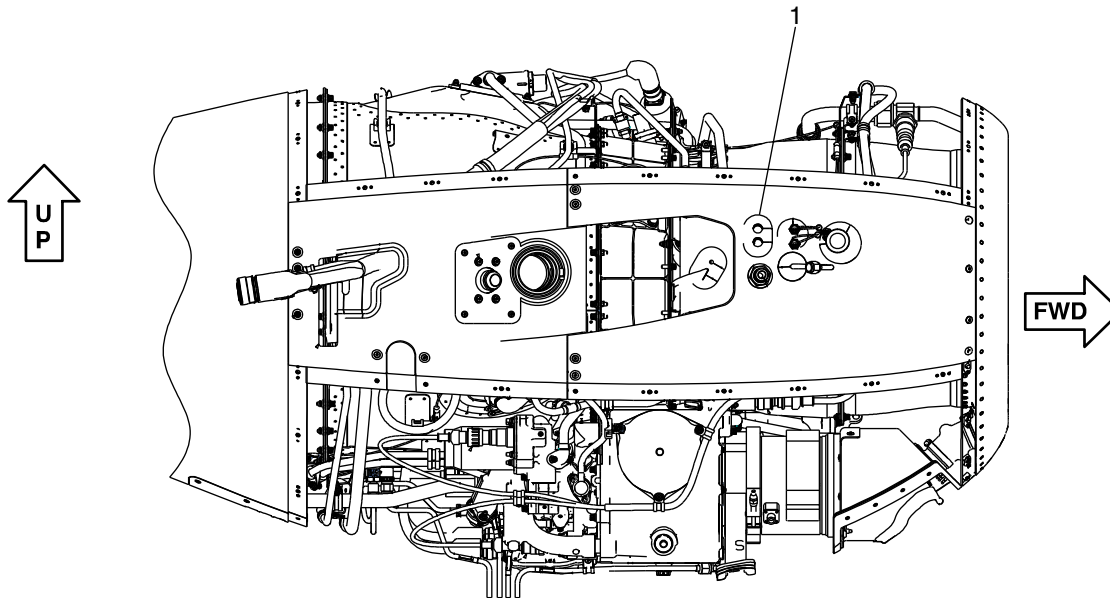
**Starter Generator Cable Grommet Apron Installation  
Figure 1**

To eliminate the possibility of starter generator cables chafing against the aircraft structure.

- (1) Remove and discard starter generator cable grommet P/N 71-117748-2001 (1, [Figure 1](#)) by carefully cleaning and removing the Fast block 100 from the apron.

- (14) Install starter generator cable grommet P/N 71-117748-2001 into apron on both left and right sides. If necessary, lubricate the edges of grommet with isopropyl alcohol to facilitate ease of installation.

- (18) Apply Fast Block 100 sealant to starter generator cable grommet P/N 71-117748-2001 at the apron with a scraper, sealing all openings. Make sure to apply sealant on both sides (inside and outside) of the apron.

- (19) Clean-up and smooth out Fast Block 100 with a paint brush. Make sure to remove all excess sealant from the apron.
