# SERVICE BULLETIN

**NUMBER:** SB 500-71-002, REV B  
**MODEL:** ECLIPSE EA500  
**SUBJECT:** LH/RH ACS GROMMET INSPECTION/REWORK

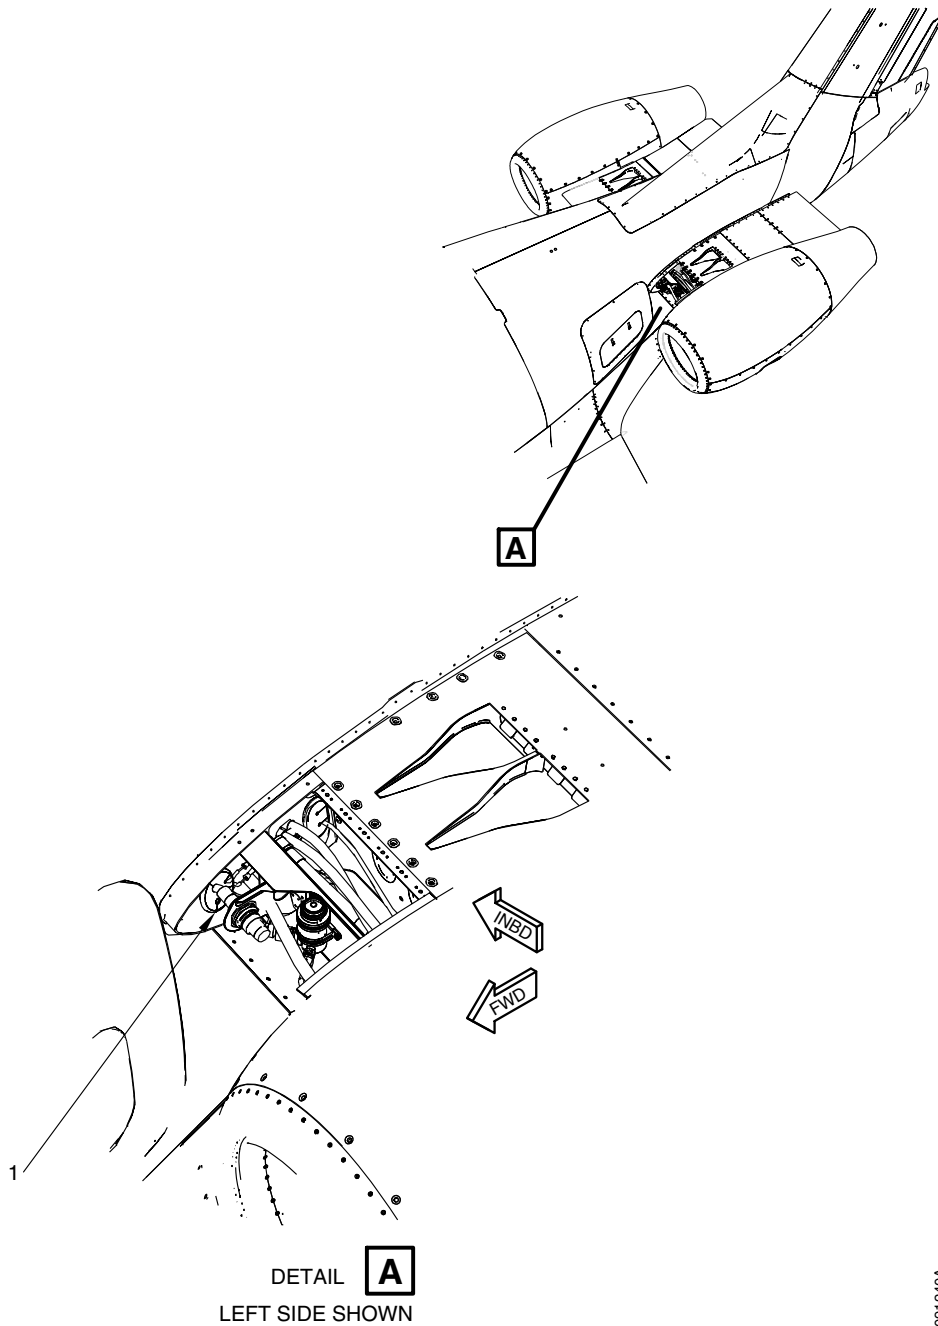
ACS Cable Grommet  
Figure 1

To eliminate the possibility of the ACS wiring from chafing against the aircraft structure.

- (1) Remove grommet (Figure 1) (P/N 71-117855-2001) from apron and detach cables and wires from grommet. Discard grommet.

- (2) Remove all sealant or adhesive from aircraft skin and apron in area where grommets were removed with a non-metallic scraper.
- (3) Install ACS cable grommet (P/N 71-117855-2002) into fuselage openings. If necessary, lubricate the edges of grommet with isopropyl alcohol to facilitate ease of installation.
  - (a) Route harnesses and wires as shown in (Figure 2).

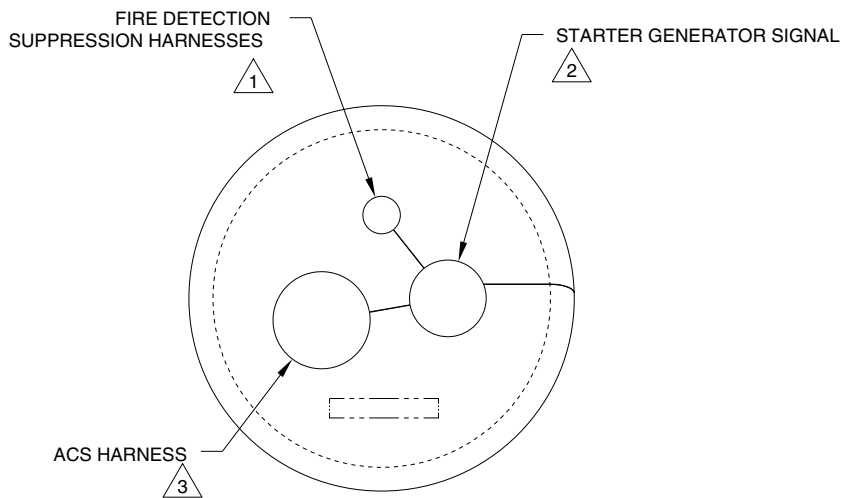
**Wire Routing  
Figure 2**

- △1 WIRES THROUGH GROMMET HOLE:  
(LH) ENG-L0612-22, ENG-L0613-22,  
ENG-L0682-22, ENG-L0690-22N, ENG-L0700-22N  
(RH) ENG-R0612-22, ENG-R0613-22  
ENG-R0682-22, ENG-R0690-22N, ENG-R0700-22N
- △2 WIRES THROUGH GROMMET HOLE:  
(LH) HARNESS 24-117703  
(RH) 24-117704
- △3 WIRES THROUGH GROMMET HOLE:  
(LH) HARNESS 39-108869 (ALL WIRES  
GOING TO CONNECTOR 72A01J02)  
(RH) HARNESS 39-108874 (ALL WIRES  
GOING TO CONNECTOR 72A02J02)

- (4) Clean area around grommet.
- (5) Apply Dow Corning (DC-732) all around the edges of ACS cable grommet (P/N 71-117855-2002) at the fuselage skin, sealing all openings. Make sure to remove all excess adhesive from the fuselage skin.
