NUMBER: SB 550-21-001, Rev B  
MODEL: ECLIPSE 550®  
SUBJECT: GDCA Gap Inspection

## 1. PLANNING INFORMATION

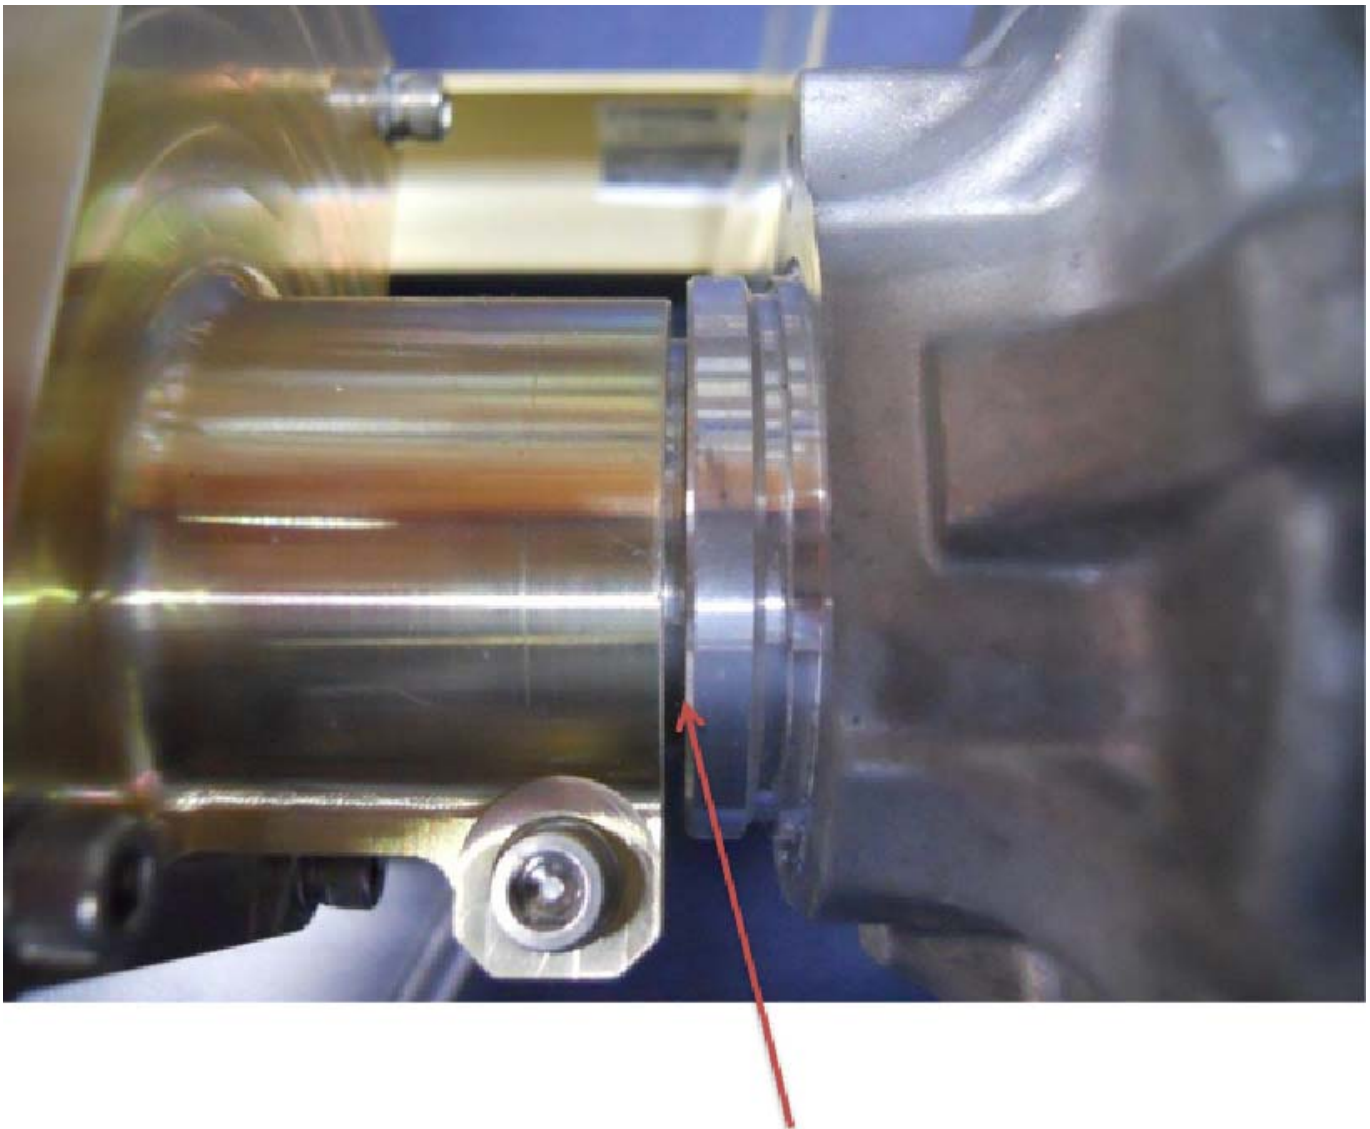
**Figure 1. Gap Inspection**

- (1) Make aircraft safe for maintenance. Refer to AMM 20-00-01- MAKE SAFE FOR MAINTENANCE.
- (2) Gain access to the VCS by removing 211 CT - Nose Access Panel. Refer to AMM-53-10-11-001-801 – Nose Access Panel - Removal.
- (3) Measure the gap between the retention collar and the compressor bearing hub. Measure in at least two places 180 degrees apart. Gap between the gearbox retention collar and compressor bearing hub to be less than .071” upon assembly of the compressor to the gearbox.
- (4) If the gap is too large, remove and replace the GDCA per 06-117751-TR21-2 AMM Temporary revision, VSC-GDCA Upgrade Option.
