NUMBER: SB 550-24-002, Rev B
MODEL: ECLIPSE 550®
SUBJECT: External Power Receptacle Inspection

Mandatory

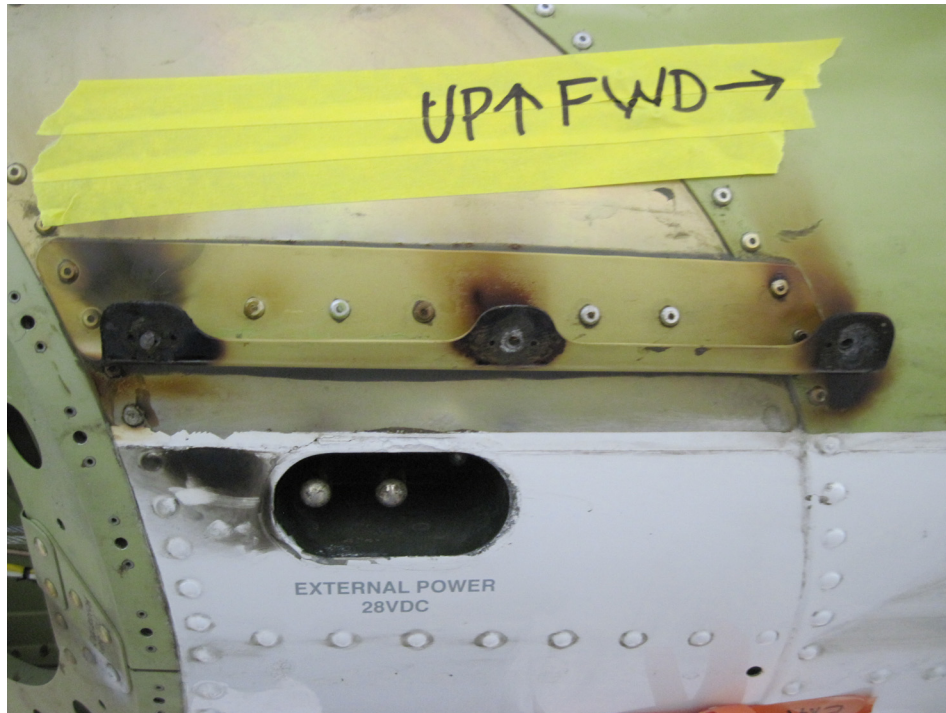
- (1) Make the aircraft safe for maintenance. Refer to AMM 20-00-01 MAKE SAFE FOR MAINTENANCE.
- (2) Gain access to the interior of the External Power Receptacle by removing:
 - (a) The 251 FL - Left Aft Wing-to-Body Fairing, per AMM-53-11-13.
 - (b) The 252 EL - Right Aft Wing-to-Body Fairing, per AMM-53-11-13.
 - (c) The 321 DB - Vertical Access Panel, per AMM-55-30-13.
- (3) Perform a DVI (Detailed Visual Inspection) of the wing-to-body fairing heat-related damage. Refer to Figure 1 through Figure 3 for examples of external electrical damage.

Typical fairing external damage may be:

Figure 1. Electrical Damage Example

- discoloration of fasteners or structure
 - material erosion along edges
 - Corrosion as evidenced by white powder (Aluminum Oxide) buildup
- (5) If evidence of damage is found, contact Eclipse Service Engineering for additional instructions.
- (6) Remove all tools, equipment and unwanted material from the work area.
- (7) Reinstall the following:
 - (a) The 251 FL - Left Aft Wing-to-Body Fairing, per AMM-53-11-13.
 - (b) The 252 EL - Right Aft Wing-to-Body Fairing, per AMM-53-11-13.
 - (c) The 321 DB - Vertical Access Panel, per AMM-55-30-13.
- (8) If all other maintenance is complete, return the aircraft to service. Refer to the AMM 20-00-02 RETURN TO SERVICE (AFTER MAINTENANCE).

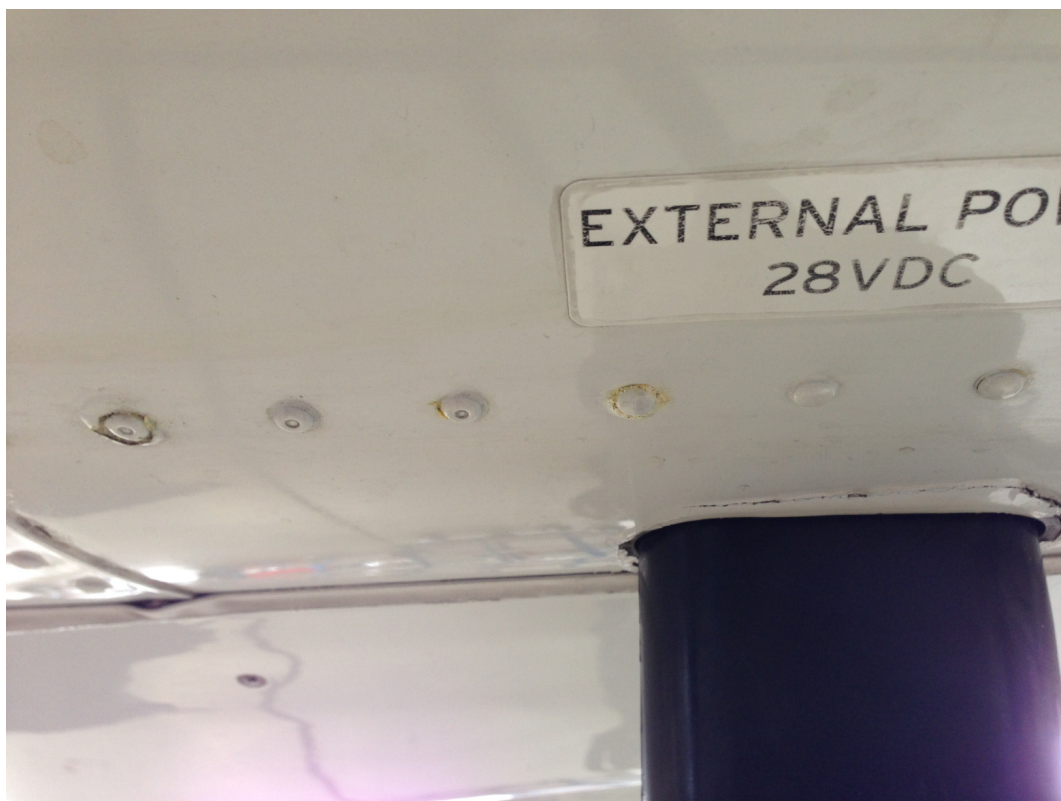
Figure 2. External Power Receptacle Rivet Corrosion

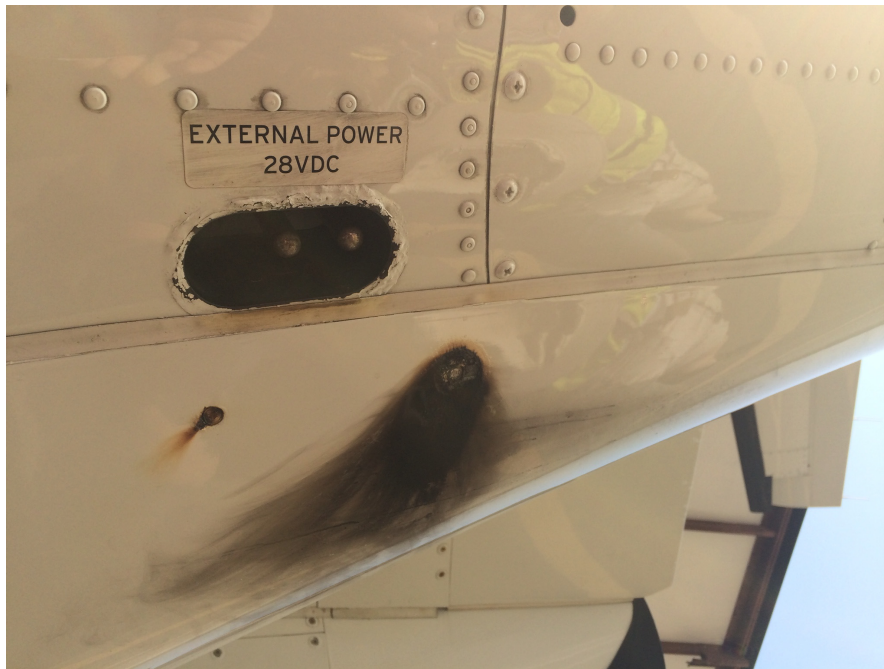
Figure 3. External Electrical Damage

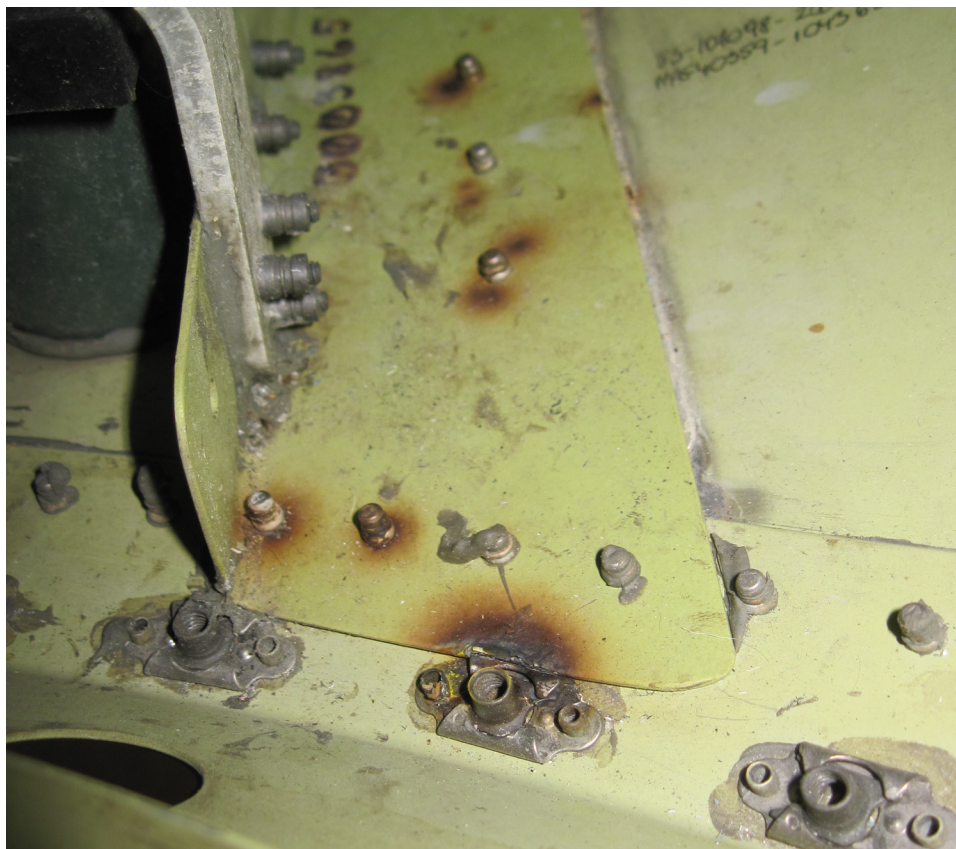
- scorching of fasteners or structure
 - discoloration of fasteners or structure
 - missing material
- (4) Perform a DVI (Detailed Visual Inspection) of the External Power Receptacle Installation for corrosion and heat-related damage. Refer to Figure 4 through Figure 6 for examples of internal electrical damage.

Typical internal damage may be:

Figure 4. Internal Electrical Damage

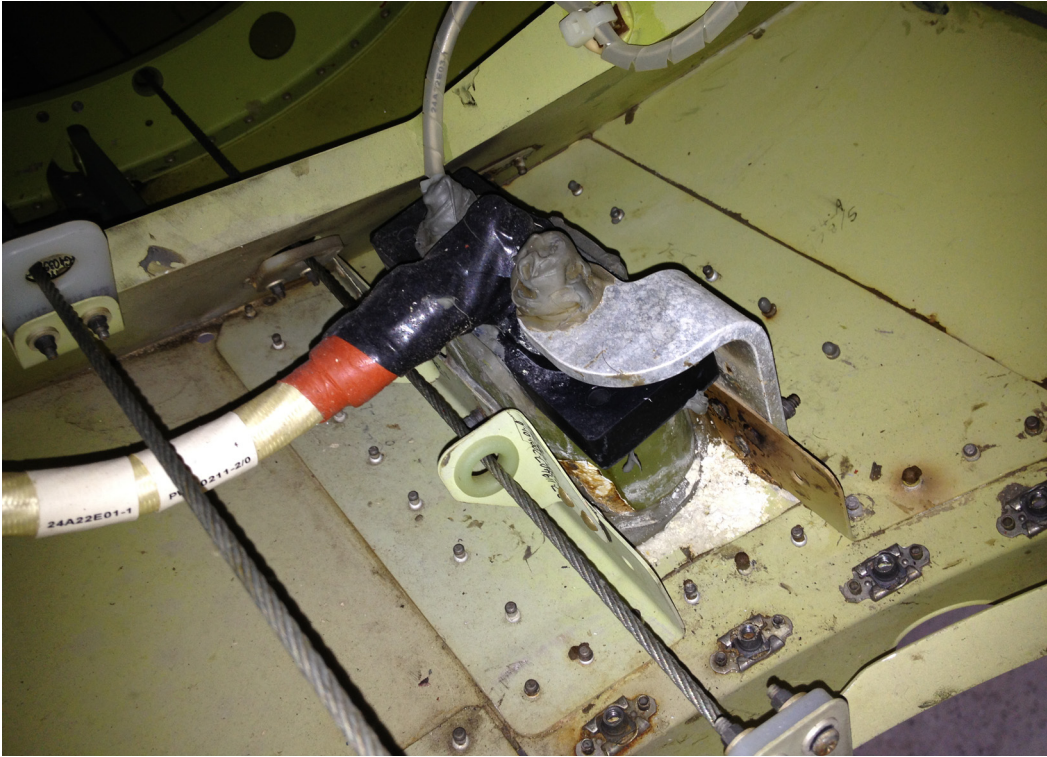
Figure 5. Internal Electrical Damage

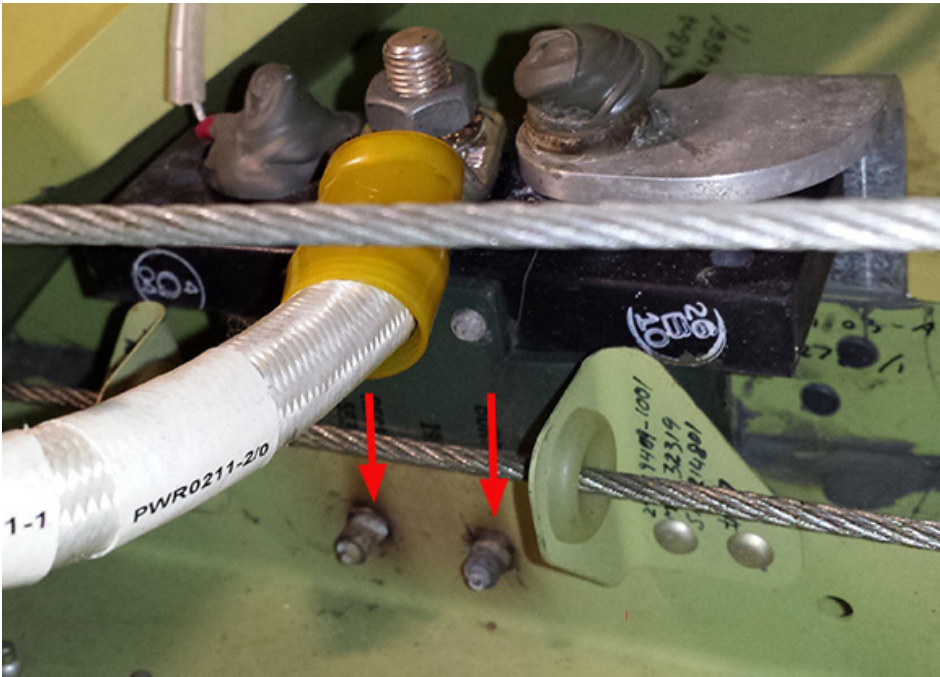
Figure 6. Internal Electrical Damage
