NUMBER: SB 550-54-001, Rev A  
MODEL: ECLIPSE EA550  
SUBJECT: Right Pylon Inspection and Repair

This Service Bulletin provides instructions to inspect and repair structure where the right pylon frame attaches to the fuselage.

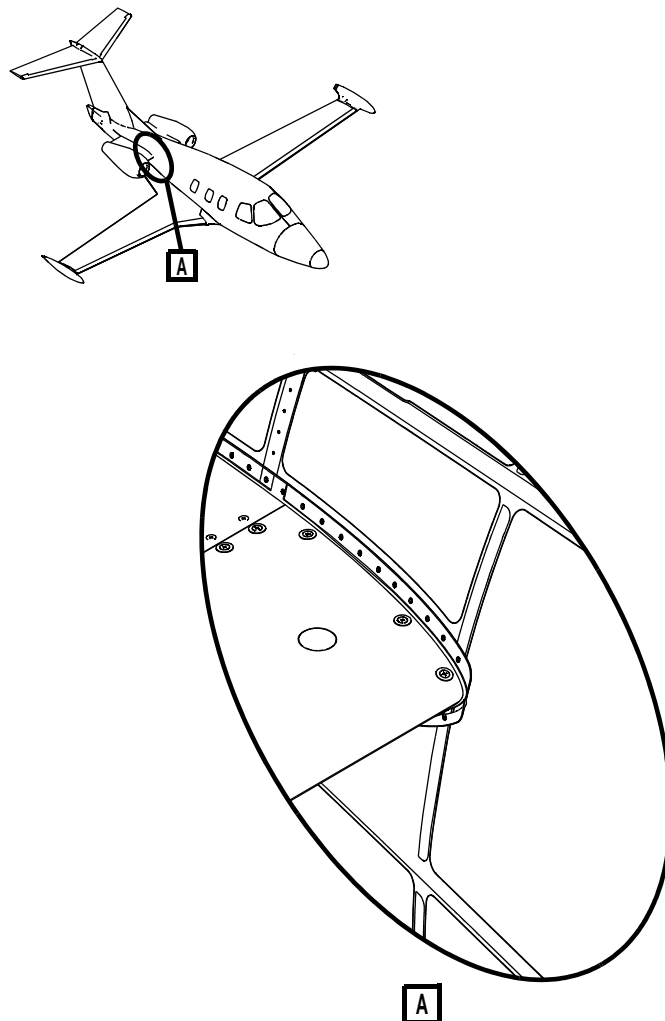
- (1) Inspect the area where the Frame, Pylon, Aft Fuselage, RH (p/n 53-114187) attaches to the aft fuselage for damaged rivets. Refer to [Figure 1](#), [Figure 2](#), and [Figure 3](#).
  - (a) If damage is noted, proceed to the Repair section.

**Figure 1. Area of Inspection**

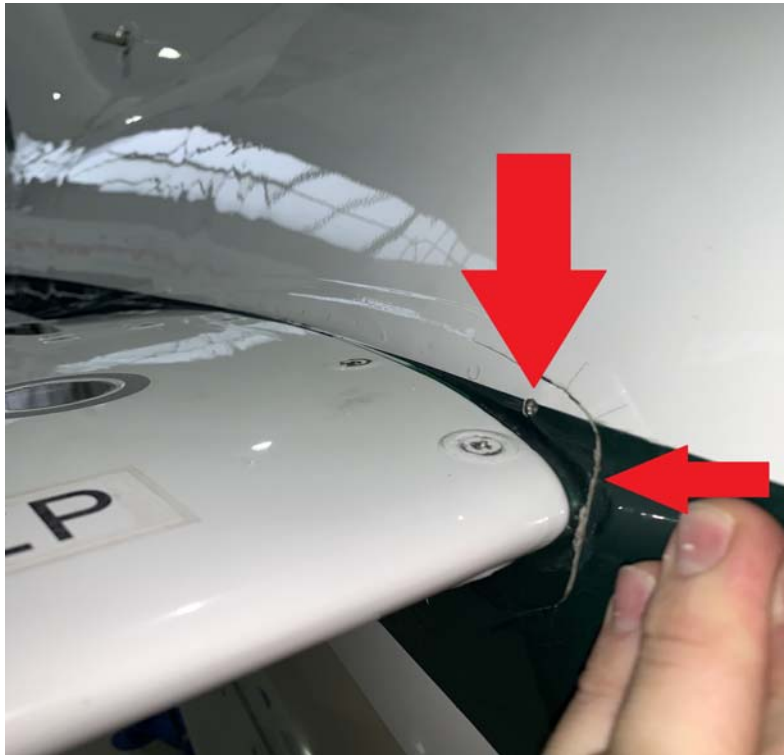
The right pylon frame attachment to the fuselage rivets may become damaged.

Figure 2. Example of Damage

- (1) Remove damaged fastener and discard.
- (2) Inspect the hole for signs of out-of-round and other indications in each of the pylon frame (outside), skin, and fuselage frame (inside).

- (7) Open each of the two holes to a final diameter of 0.1625/0.1645 in.
- (8) At each of the two locations, wet install HL12-5 pins and HL70-5 collars. Refer to SRM 51-00-00 - Standard Practices and Structures

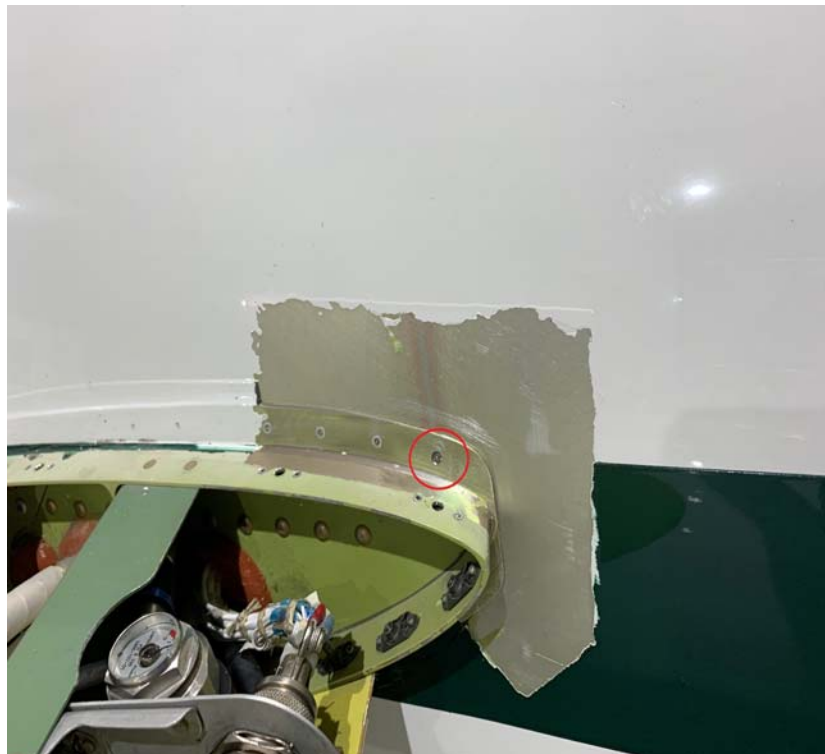
Figure 3. Example of Damage - Paint Removed
