NUMBER: SB 550-55-001, Rev A  
MODEL: ECLIPSE 550®  
SUBJECT: Elevator Drain Hole Inspection

**Mandatory**  
www.ECLIPSE.aero®

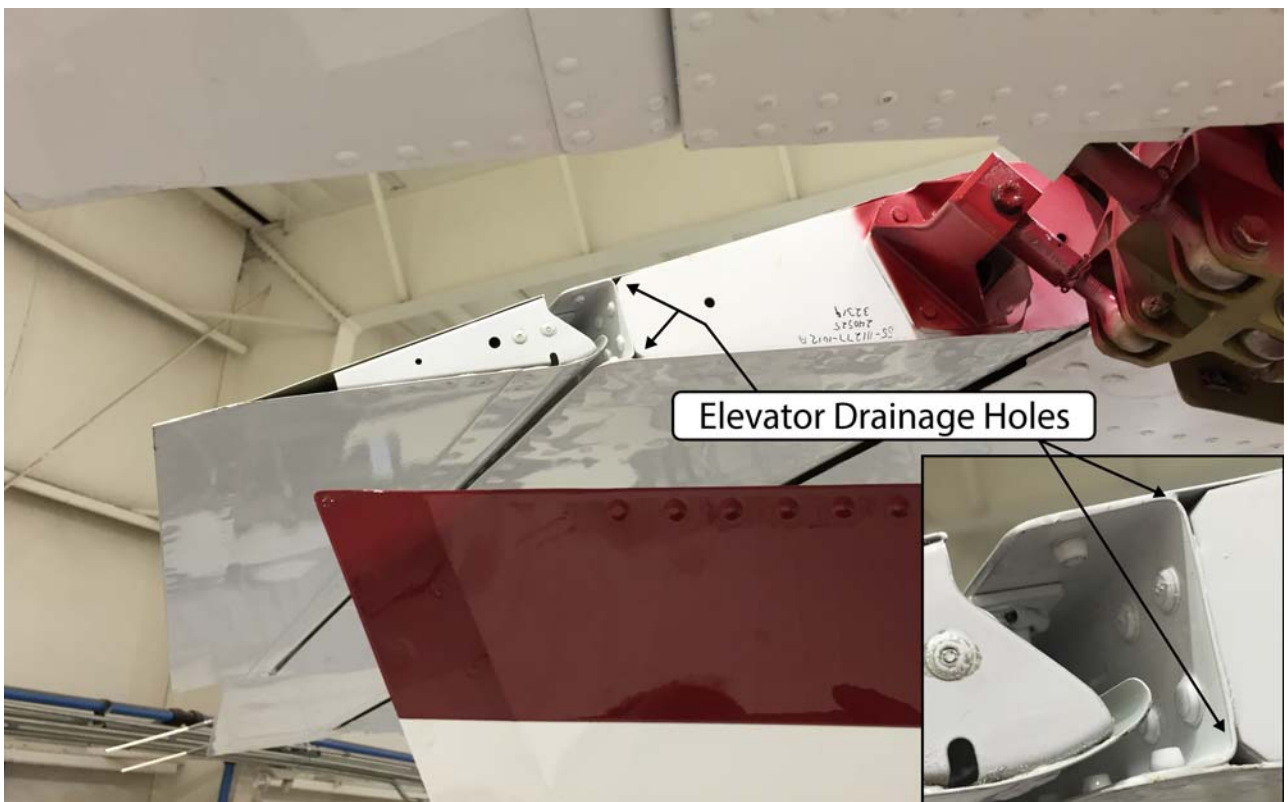
**Figure 1. Elevator Drainage Holes**

This Service Bulletin inspects the elevator drain holes for blockage.

- (1) Remove the Overfin Fairing. Refer to AMM 55-10-12-001- Overfin Fairing - Removal.
- (2) Ensure the drainage holes for the left and right elevators are completely free and clear from obstruction (e.g. paint, sealant, etc.), a minimum of 1.5 inch deep in from the opening, using a small diameter non-metallic probe, see [Figure 1](#).
- (3) Any holes that are partially or fully obstructed shall be cleared of the obstruction using the following method:
  - (a) Using a non-metallic trowel or punch-like implement, remove the obstruction down to the surface finish of the surrounding parts.
  - (b) Ensure obstruction is free and clear a minimum of 1.5 inch deep in from the opening.
- (4) Replace the Overfin Fairing. Refer to AMM 55-10-12-041- Overfin Fairing - Installation.
