NUMBER: SB 500-57-013, Rev A
MODEL: ECLIPSE EA500
SUBJECT: Wing Corrosion Inspection

Corrosion has been found on the underside of wings on fielded aircraft.

This Service Bulletin provides instructions to inspect the undersides of wings for corrosion.

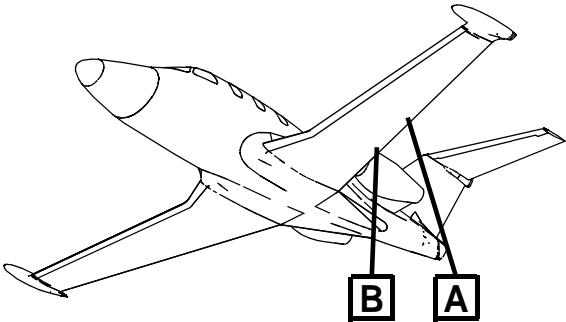
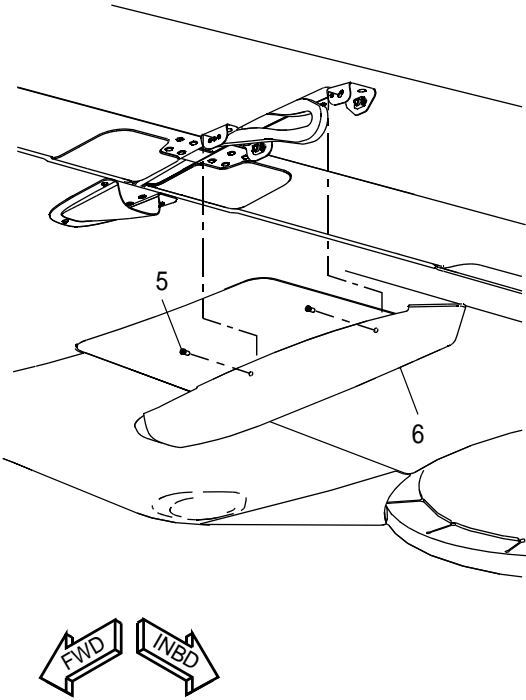
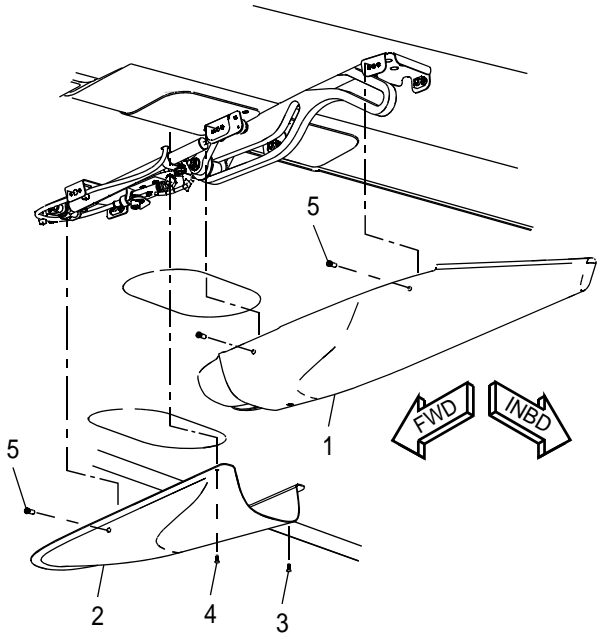
Figure 1. Mid and Outboard Flap Track Removal

1. Remove Outboard Flap Track Fairing, Aft, (LH) (1, [Figure 1](#)) and (RH) by removing four Screws – P/N NAS8702-2 (5, [Figure 1](#)).

1. Remove Outboard Flap Track Fairings, Aft (LH) (1, [Figure 1](#)) and (RH) by removing four Screws – P/N NAS8702-2 (5, [Figure 1](#)).

1. Remove Outboard Flap Track Fairing, Forward (LH) (2, [Figure 1](#)) and (RH) by removing Screws – P/N NAS7702-2 (3, [Figure 1](#)), P/N NAS7702-3 (4, [Figure 1](#)) and two P/N NAS8702-2 (5, [Figure 1](#)).

1. Remove Mid Flap Track Fairing, Aft (LH) (6, [Figure 1](#)) and (RH) by removing four Screws – P/N NAS8702-2 (5, [Figure 1](#)).

- (1) Install the access panels that follow:
 - (a) Aircraft PRE SB 500-57-008, LH and RH Outboard Flap Track Fairings, Aft:
 1. Install Outboard Flap Track Fairing, Aft, (LH) (1, [Figure 1](#)) and (RH) with four Screws – P/N NAS8702-2 (5, [Figure 1](#)).

1. Install Outboard Flap Track Fairings, Aft (LH) (1, [Figure 1](#)) and (RH) with four Screws – P/N NAS8702-2 (5, [Figure 1](#)).
 2. Fay seal points of contact on fairing with PR-2001.

1. Install Outboard Flap Track Fairing, Forward (LH) (2, [Figure 1](#)) and (RH) with Screws – P/N NAS7702-2 (3, [Figure 1](#)), P/N NAS7702-3 (4, [Figure 1](#)) and two P/N NAS8702-2 (5, [Figure 1](#)).

1. Mid Flap Track Fairing, Aft (LH) (6, [Figure 1](#)) and (RH) with four Screws – P/N NAS8702-2 (5, [Figure 1](#)).
 2. Fay seal points of contact on fairing with PR-2001.

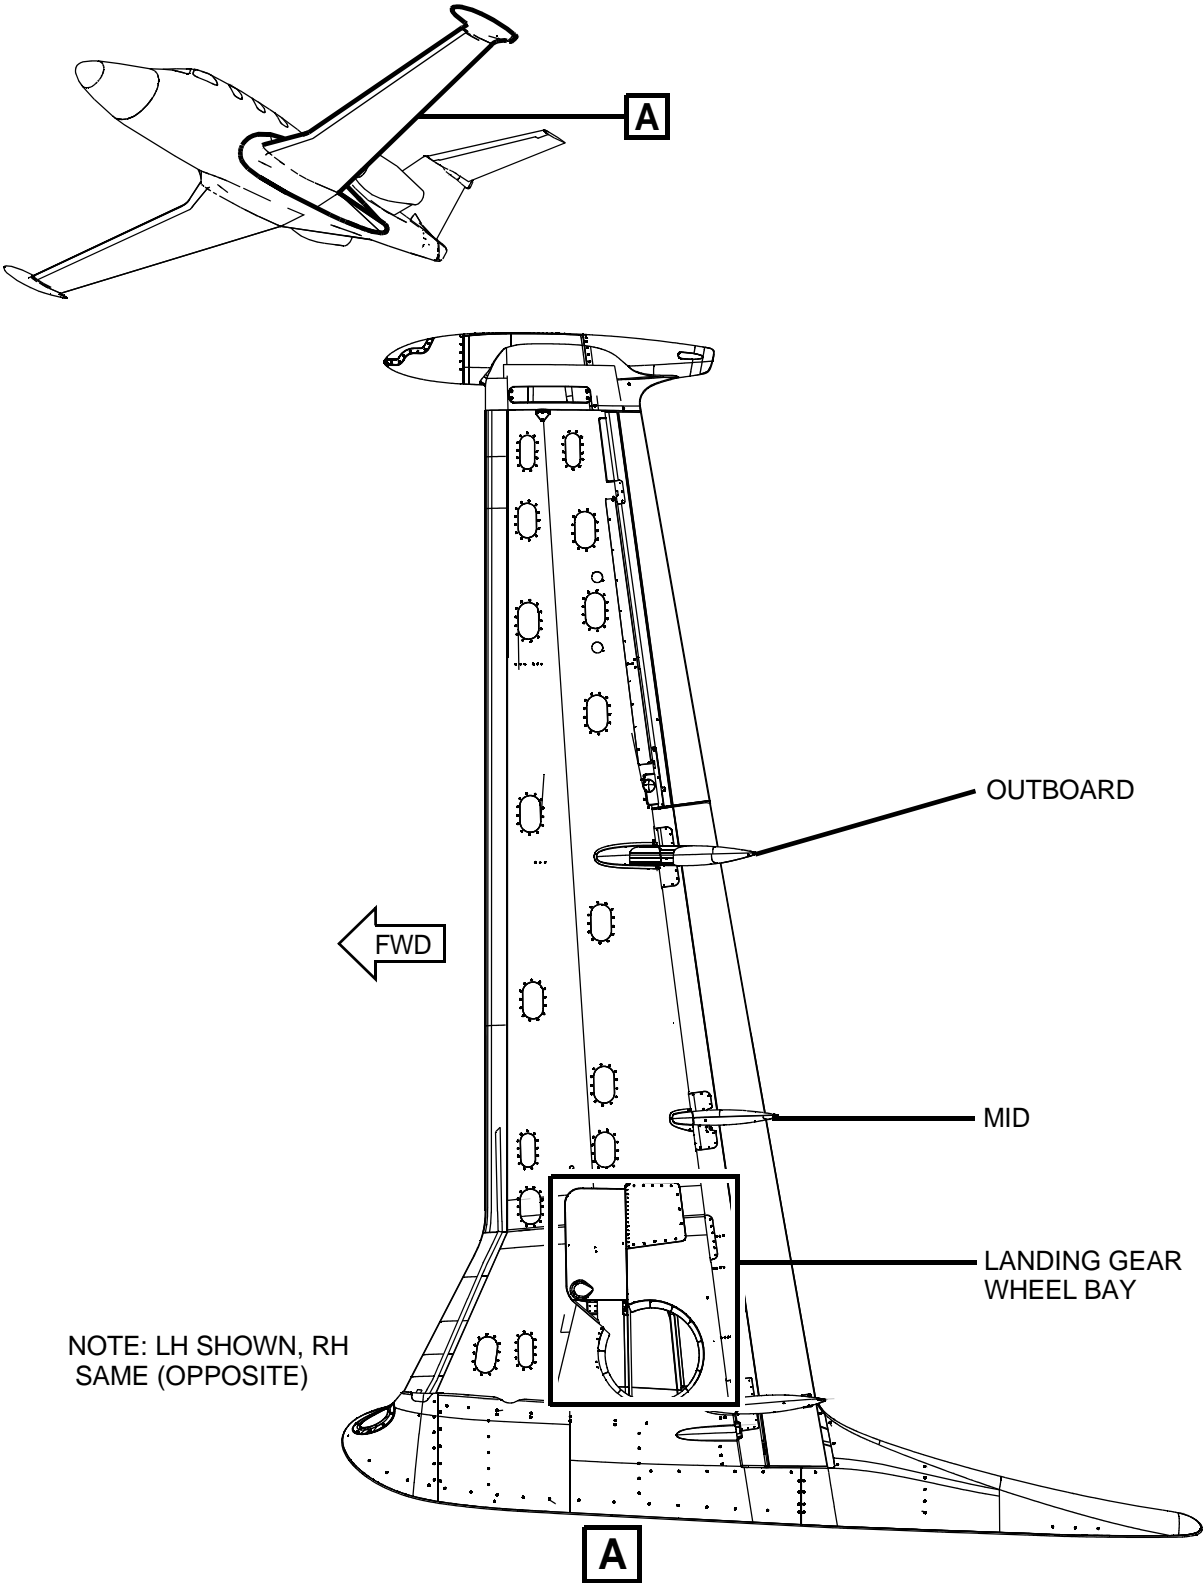
Figure 2. Wing Corrosion Inspection

- (1) Aircraft PRE SB 500-57-008; with a flashlight and mirror, inspect the area inside the Outboard Flap Track Fairing, Forward for corrosion. Inspect the outside perimeter of the Outboard Flap Track Fairing, Forward where it attaches to the wing for corrosion.

- (2) Aircraft post SB 500-57-008; inspect the area where the Outboard Flap Track Fairings, Forward and Aft attaches to the wing and flap for corrosion.

- (3) With a flashlight and mirror, inspect the area inside the Mid Flap Track Fairing, Forward for corrosion. Inspect the outside perimeter of the Mid Flap Track Fairing, Forward where it attaches to the wing for corrosion.

- (4) Inspect the area on the flap where the Mid Flap Track Fairing, Aft attaches to the flap for corrosion.
- (5) Inspect the Landing Gear Bay for corrosion:

- (7) Apply Corrosion Preventive Lubricant ZIP-Chem D-5026NS or equivalent to MILPRF-81309, Type II, class 1 or 2 to the subject areas per AMM 20-10-00, SUBTASK AMM-20-10-00-051-911-006.

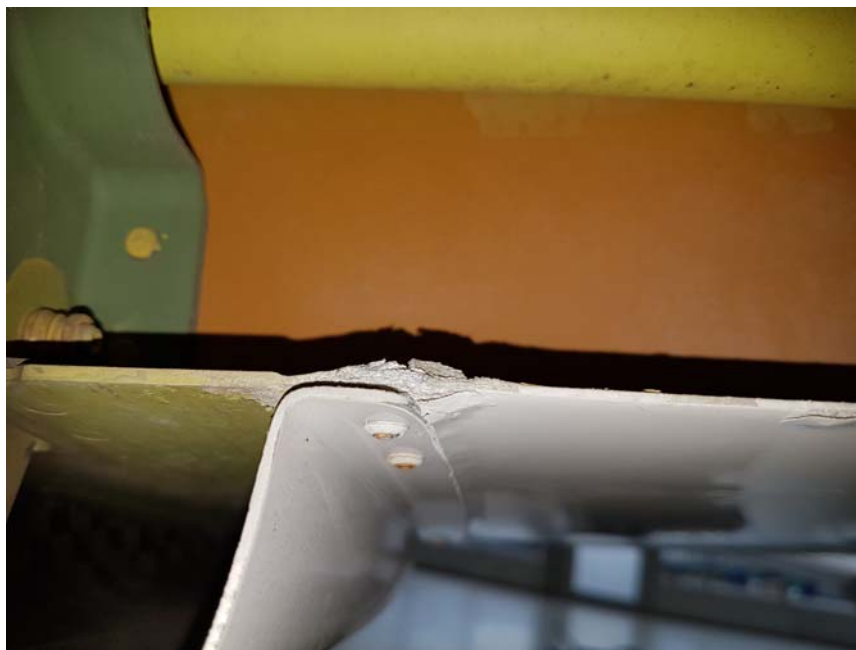
Figure 4. Example of Damage - Outboard Forward Flap Track Fairing

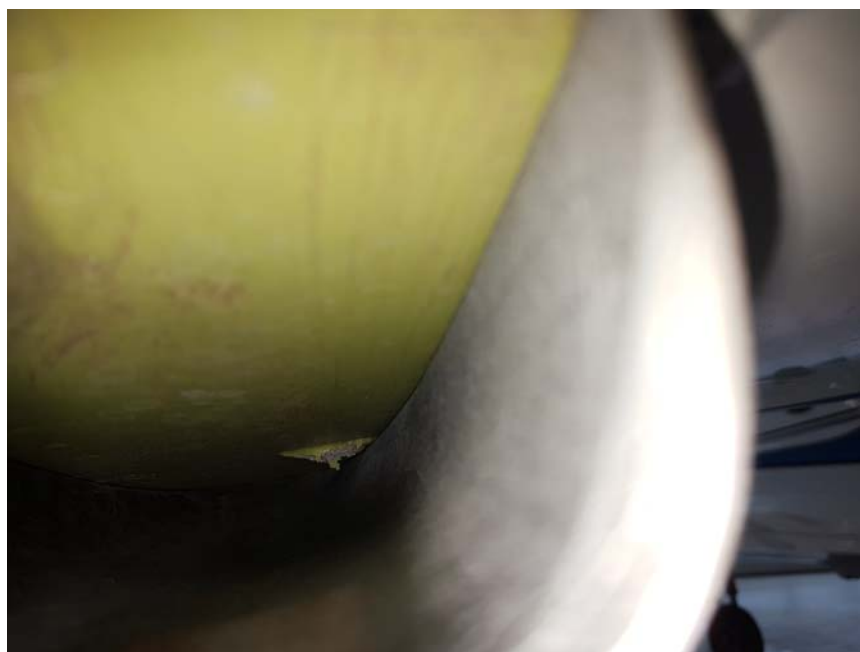
Figure 5. Example of Damage - Outboard Forward Flap Track Fairing

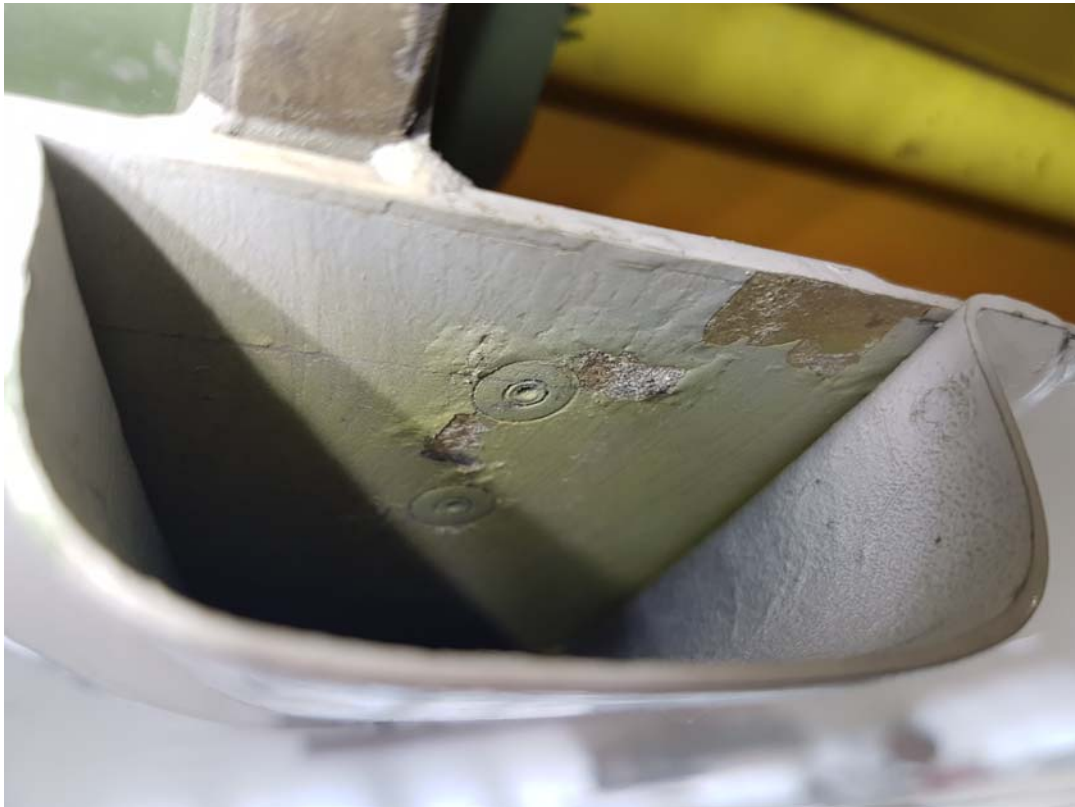
Figure 6. Example of Damage - Mid Forward Flap Track Fairing

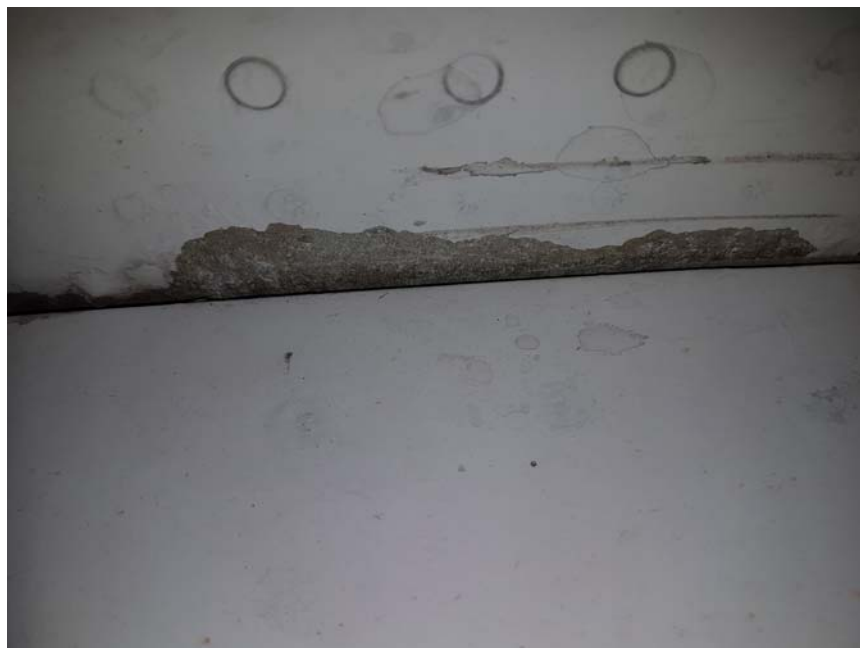
Figure 7. Example of Damage - Wing Skin at Landing Gear Door
