SUBJECT: Damaged Pitot/AOA Probe Ram Air Pneumatic Tube
Aircraft Type: Eclipse 500 and Eclipse 550®
Effectivity: All Aircraft
Applicability: All Aircraft

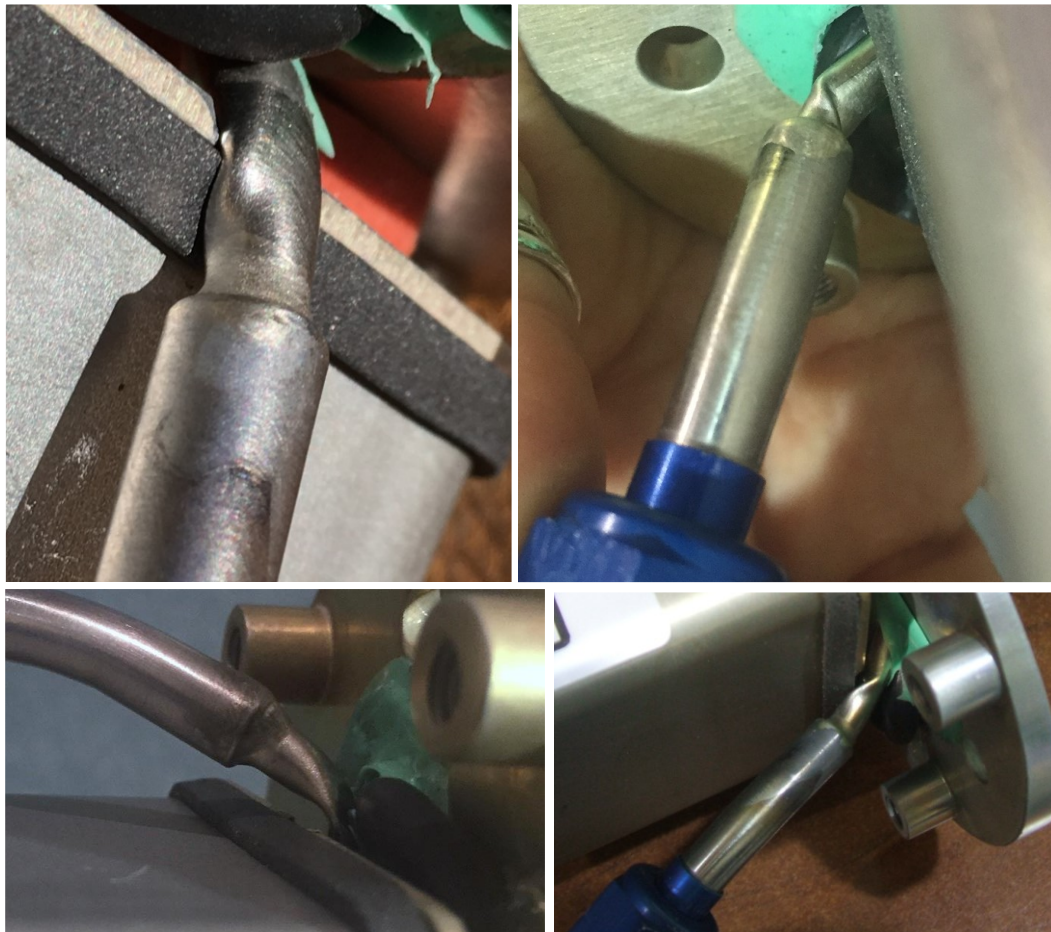
Several Pitot/AOA probes have been returned to EAI with damage to the ram air tube. The damage ranges from moderate to severe. The photos below are typical examples of the damage seen.

All of the damaged tubes in these photos are un-serviceable.

Damaged ram air tubes are not repairable or replaceable. The Pitot/AOA probe must be replaced. A damaged ram air tube causes the entire probe head to be scrapped when the probe is sent to the manufacturer for repair.

Owners, operators, and maintainers should pay particular attention to the delicate nature of the ram air pneumatic tube on all Pitot/AOA probes during removal, installation, and shipping procedures to ensure damage does not occur.

Before removal of any Pitot/AOA probes we recommend checking the condition of the ram air tubing with a flash light and a mirror. If the tubing is found to be damaged we recommend documenting the damage with photos before removing the probe. We also recommend inspecting all Pitot/AOA probes before and after installation to ensure the probe is free of damage.

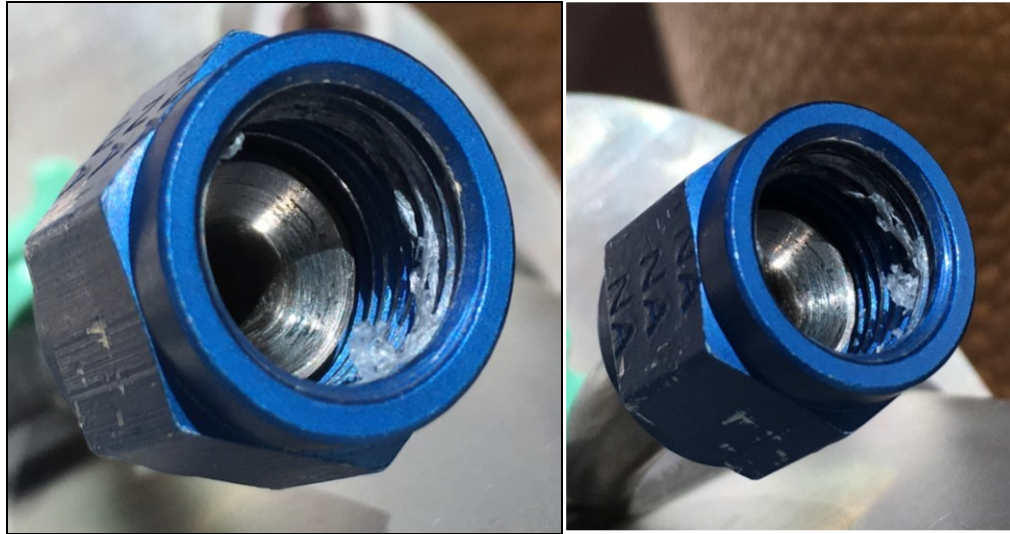
The B-nut in the photo is part of a probe that was recently received by EAI. The contamination on the threads appears to be Teflon tape.

AC 43.13-1B § 8-38 f. warns against using Teflon tape on fuel lines. The same warning applies to flared tubing lines in other systems. Never use Teflon tape or other types of thread compound on any Pitot or static lines. The tape can come between the flare and fitting which will cause leaks. Tape and thread compound can also get into the plumbing and contaminate the air data computer.

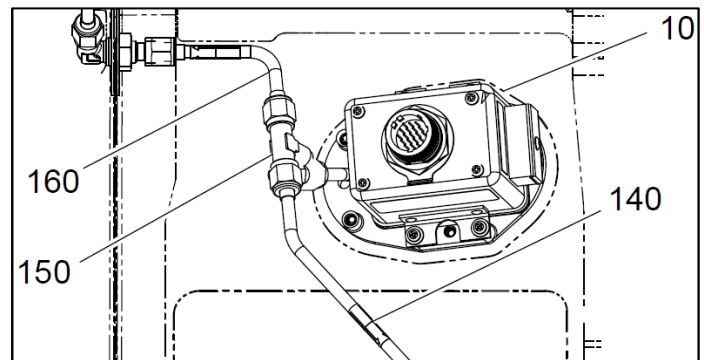
Several mechanics have found it useful to disconnect the t-fitting (item 150) from the pitot lines (items 140 and 160) versus disconnecting the ram air tube from the t-fitting. Using this technique puts less strain on the ram air tube.

EAI recommends using best shop practices to always support the b-nuts and union on the Pitot tube plumbing while torquing or loosening the b-nuts connecting the pitot plumbing to the Pitot/AOA Probe.

If the t-fitting is removed with the probe it should be removed from the old probe and re-installed on the new probe on the bench. It is part of the plane, not the probe.

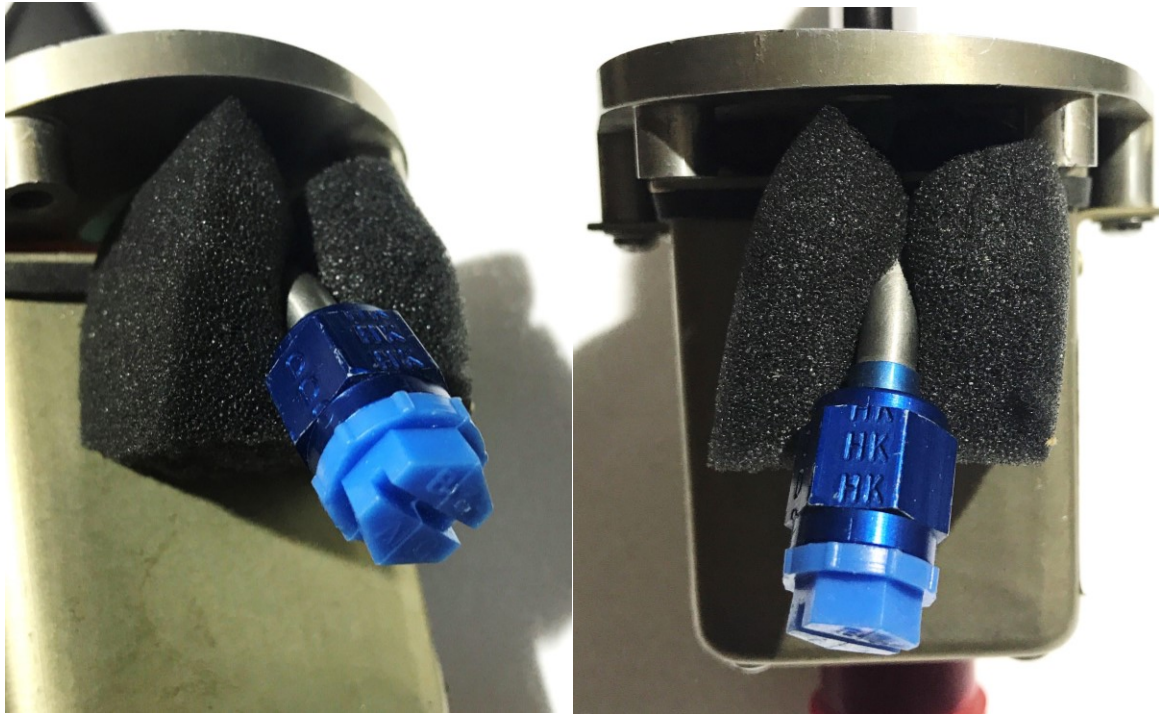
An example of the foam packing block mentioned in AMM 34-10-10-041-801, Pitot/AOA probes – installation is shown below. This should be installed any time the probe is off the aircraft.
