SERVICE BULLETIN

NUMBER: SB 500-57-005
MODEL: ECLIPSE EA500
SUBJECT: WING TIP TANK FASTENER INSPECTION-REPAIR

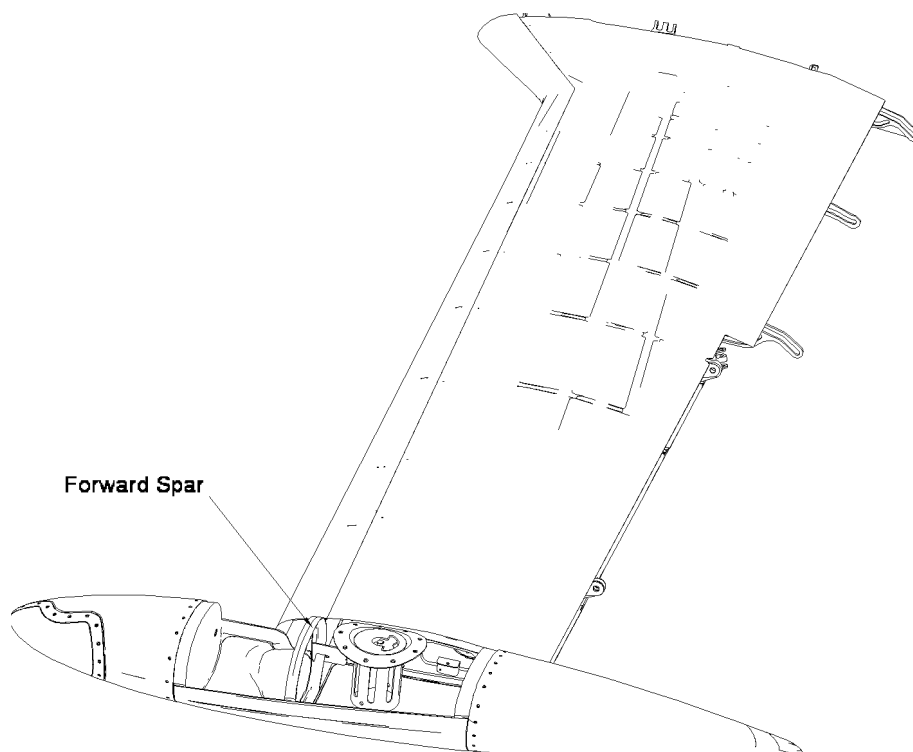
**Left Wing Tip Tank
Figure 1 (Sheet 1 of 1)**

- (1) Inspect both the left and right tip tanks.
- (2) Defuel, if necessary, enough fuel to make sure that the tip tanks are empty.
- (3) Remove tip tank filler cap. Refer to AMM-28-10-10 Fuel Tank Filler Cap – Removal, Config B.
- (4) Navigating through the fuel tank filler port with a borescope, check that two fasteners are installed on the Forward Spar Former and Support as shown in Figure 2.
